NILU : OR 42/98  
REFERENCE : O-8208  
DATE : AUGUST 1998  
ISBN : 82-425-1000-8

**International Co-operative  
Programme on Effects on Materials,  
including Historic and Cultural  
Monuments**

**Evaluation of decay of painted systems for wood,  
steel and galvanized steel after 8 years exposure**

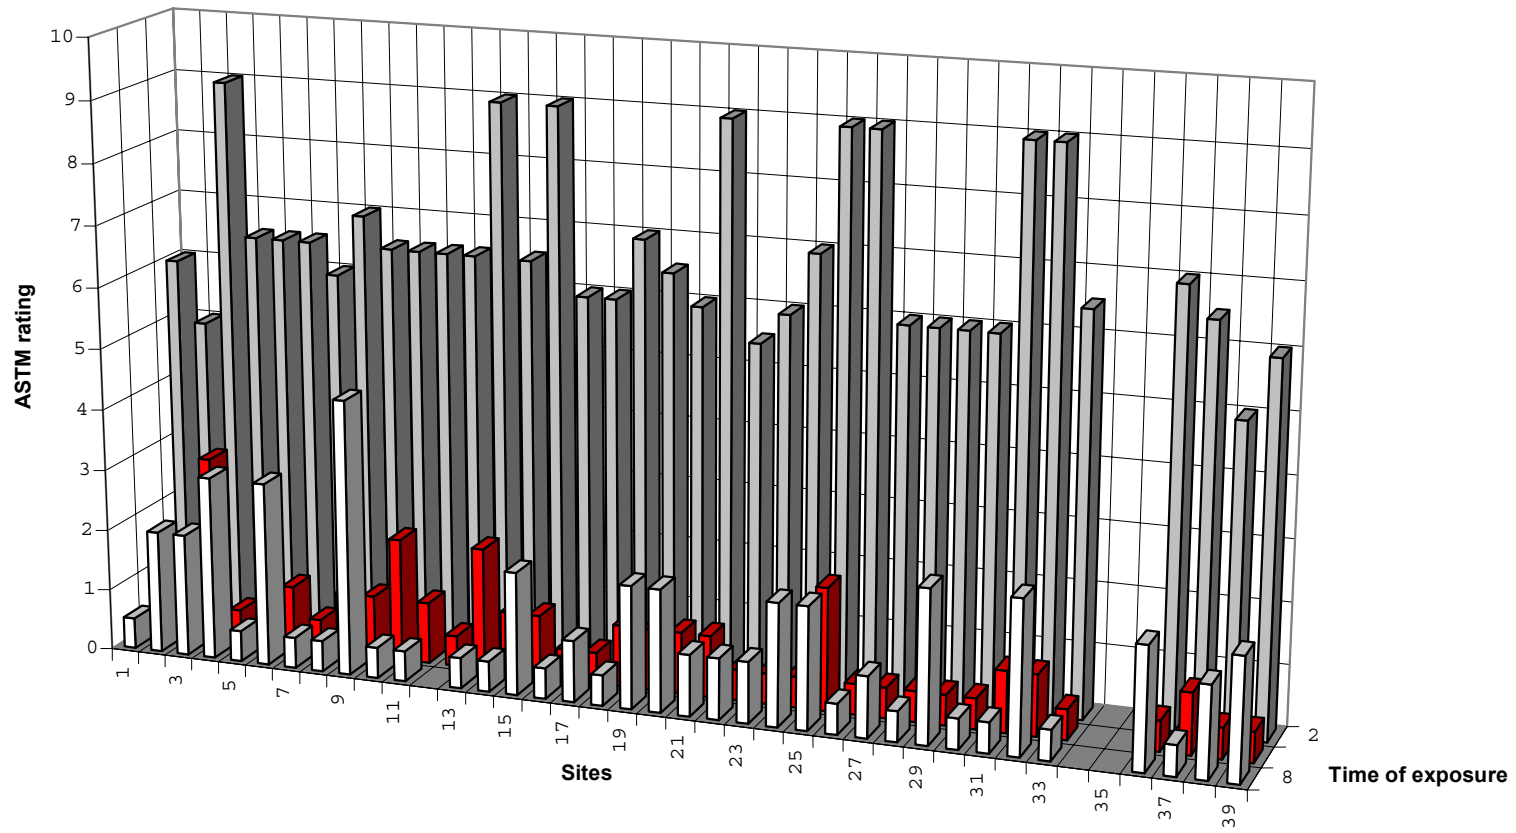
Figure 1.1: Type G. Chalking after 2, 4 and 8 years of exposure.

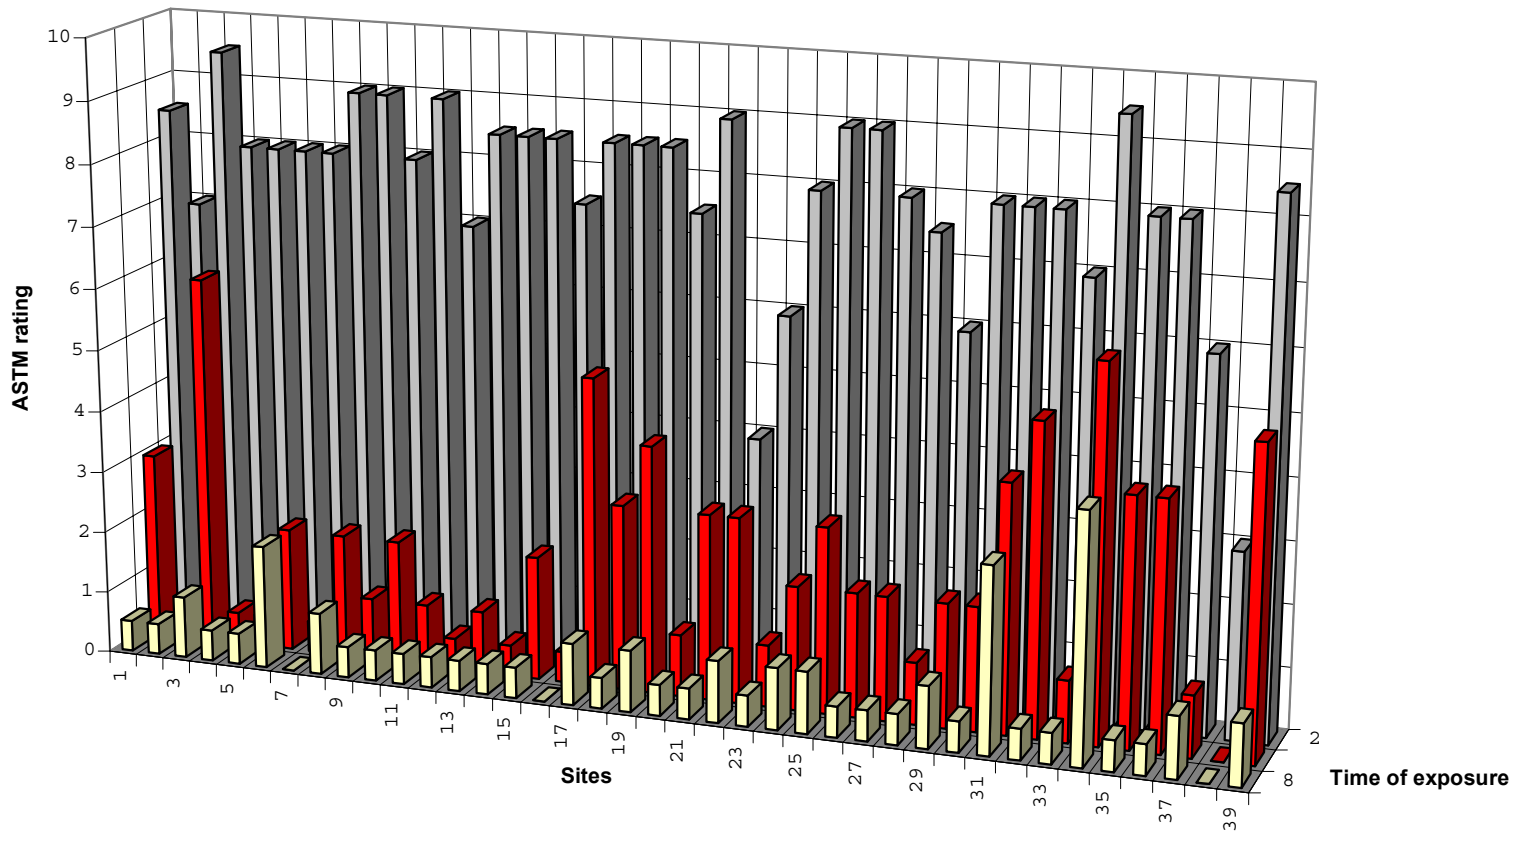
Totally we observed more chalking on type H than on type G after eight years. After four years it was vice versa.

Figure 1.2: Type H. Chalking after 2, 4 and 8 years of exposure.

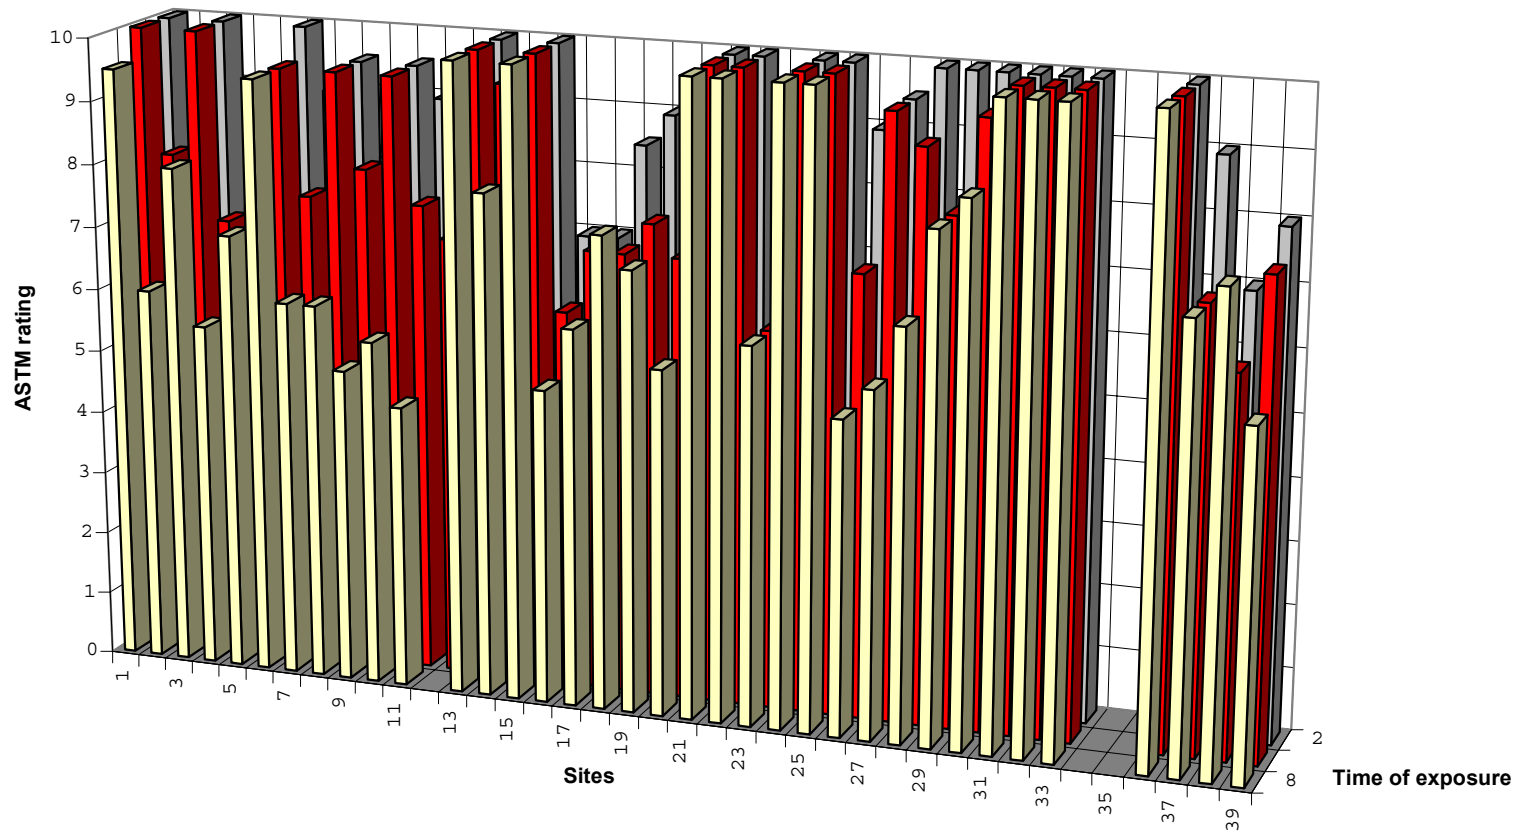
Figure 1.3: Type G. Fungus after 2, 4 and 8 years of exposure.

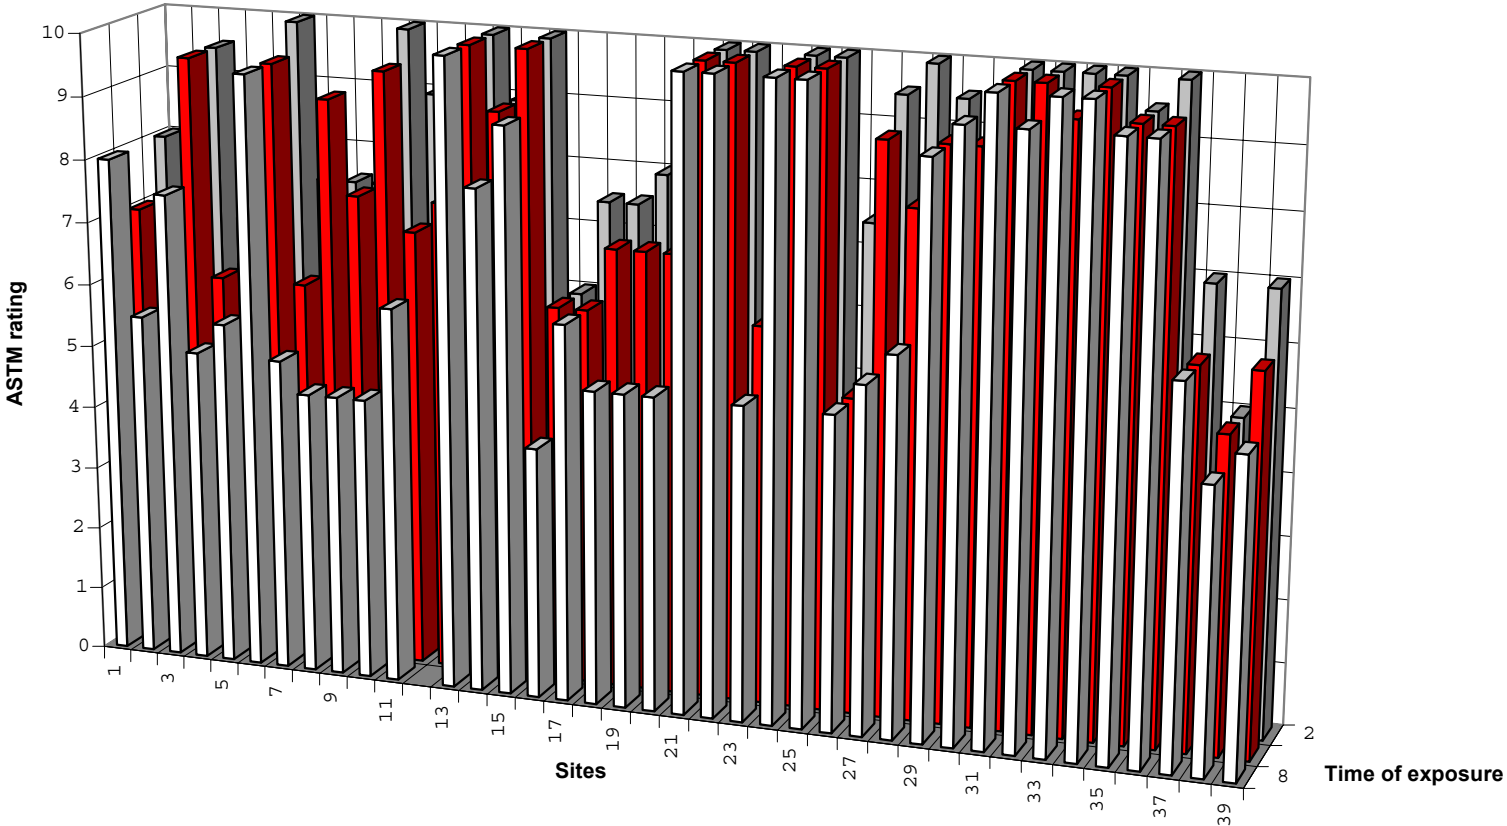
Lowest RN (= 4) we found in the site ITA 16, but the RN were also low in FRG 8, FRG 9 and FRG 10 and USA 38, all with RN = 4.5.

Figure 1.4: Type H. Fungus after 2, 4 and 8 years of exposure.

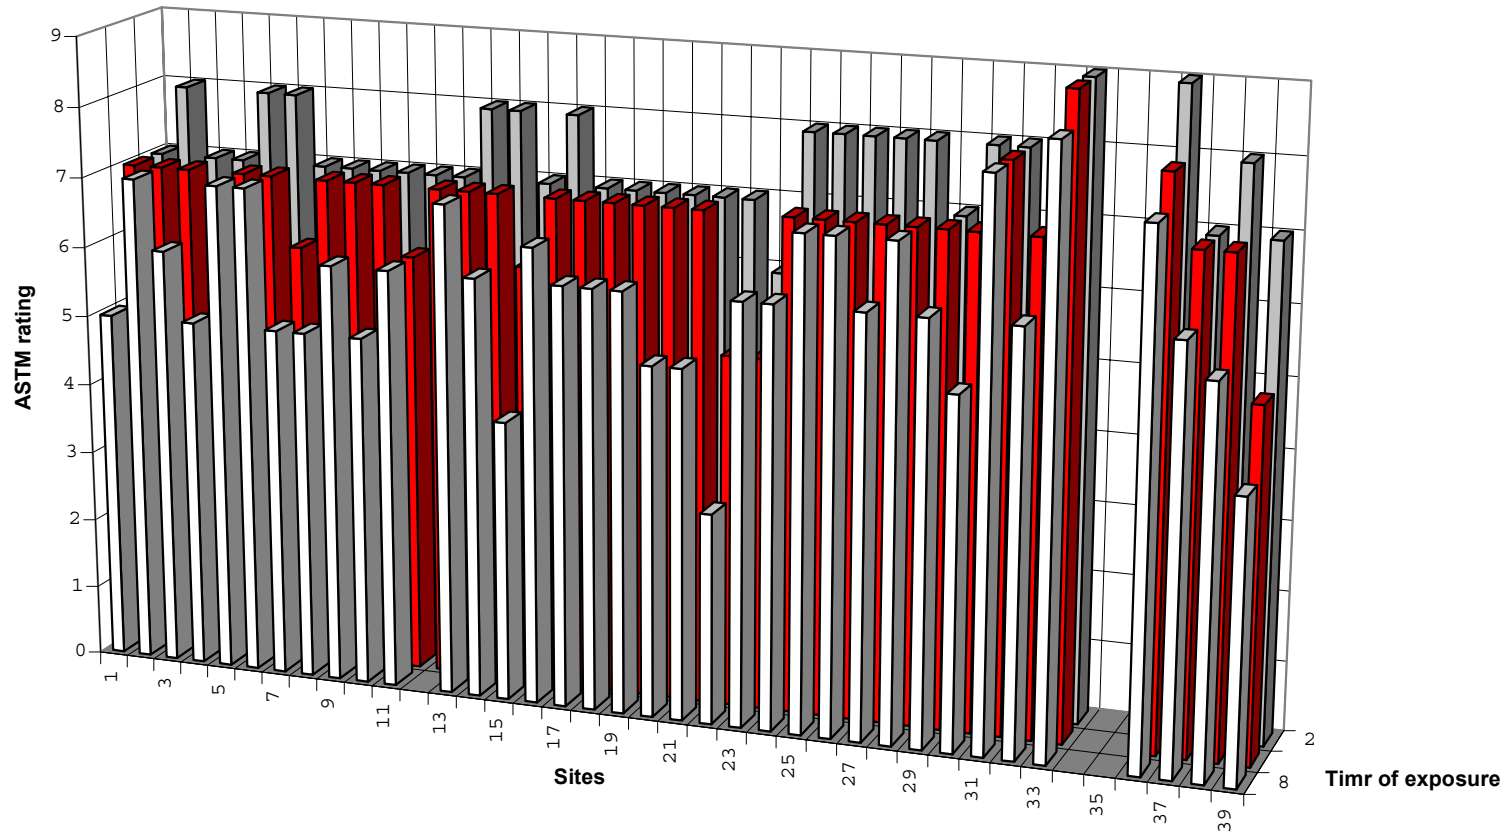
The panels of type G have no masking on the edges. This has caused the paint to creep more or less from the edge. We have made separate evaluation scale for this parameter (Annex 3). None or insignificant creepage had occurred on these sites: CS 2, FIN 5, FRG 8, SPA 31 and SPA 33, POR 36 and CAN 37. Bad was NOR 22, followed by CS 3 and UK 39 and UK 30. The results from this evaluation are found in Annex 2, Table 2.2.

Figure 1.5: Type G. Damage from cut after 2, 4 and 8 years of exposure.

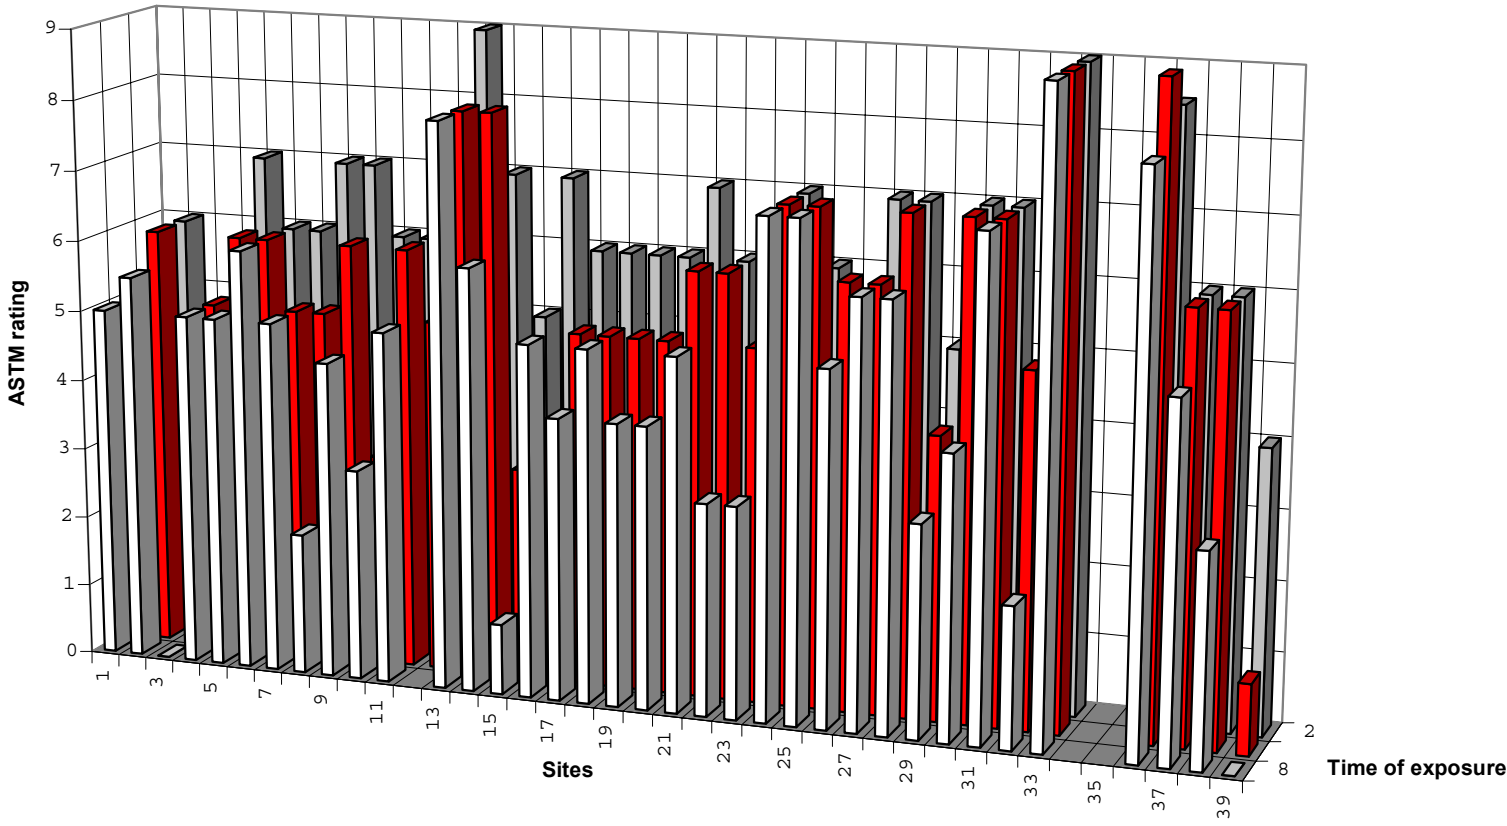
The strongest effects were observed at the industry sites, particularly for system H.

Best results we found in SPA 33 (RN = 9), ITA 13 and POR 36 (RN = 8).

The panels on following sites had serious damages in cut: CS 3 and USA 39 (RN = 0), ITA 15 (RN = 1), FRG 8 and SPA 32 (RN = 2), NOR 22 and NOR 23, UK 29 and USA 38 (RN = 3).

Figure 1.6: Type H. Damage from cut after 2, 4 and 8 years of exposure.

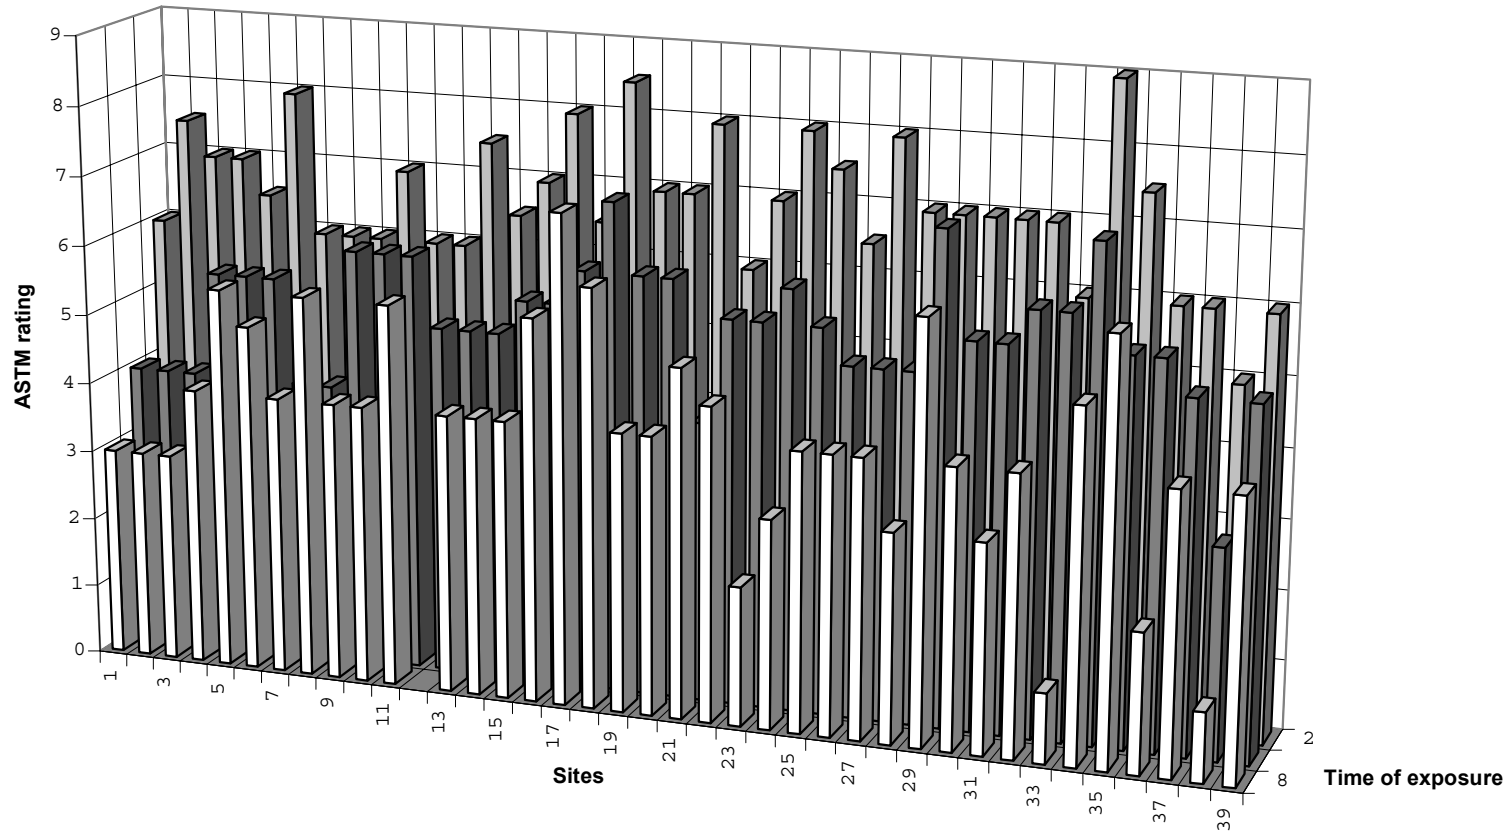
Most chalking we found on the panels at USA 38 ( $RN = 1$ ) and POR 36 ( $RN = 2$ ).

Figure 1.11: Type I. Chalking after 2, 4 and 8 years of exposure.

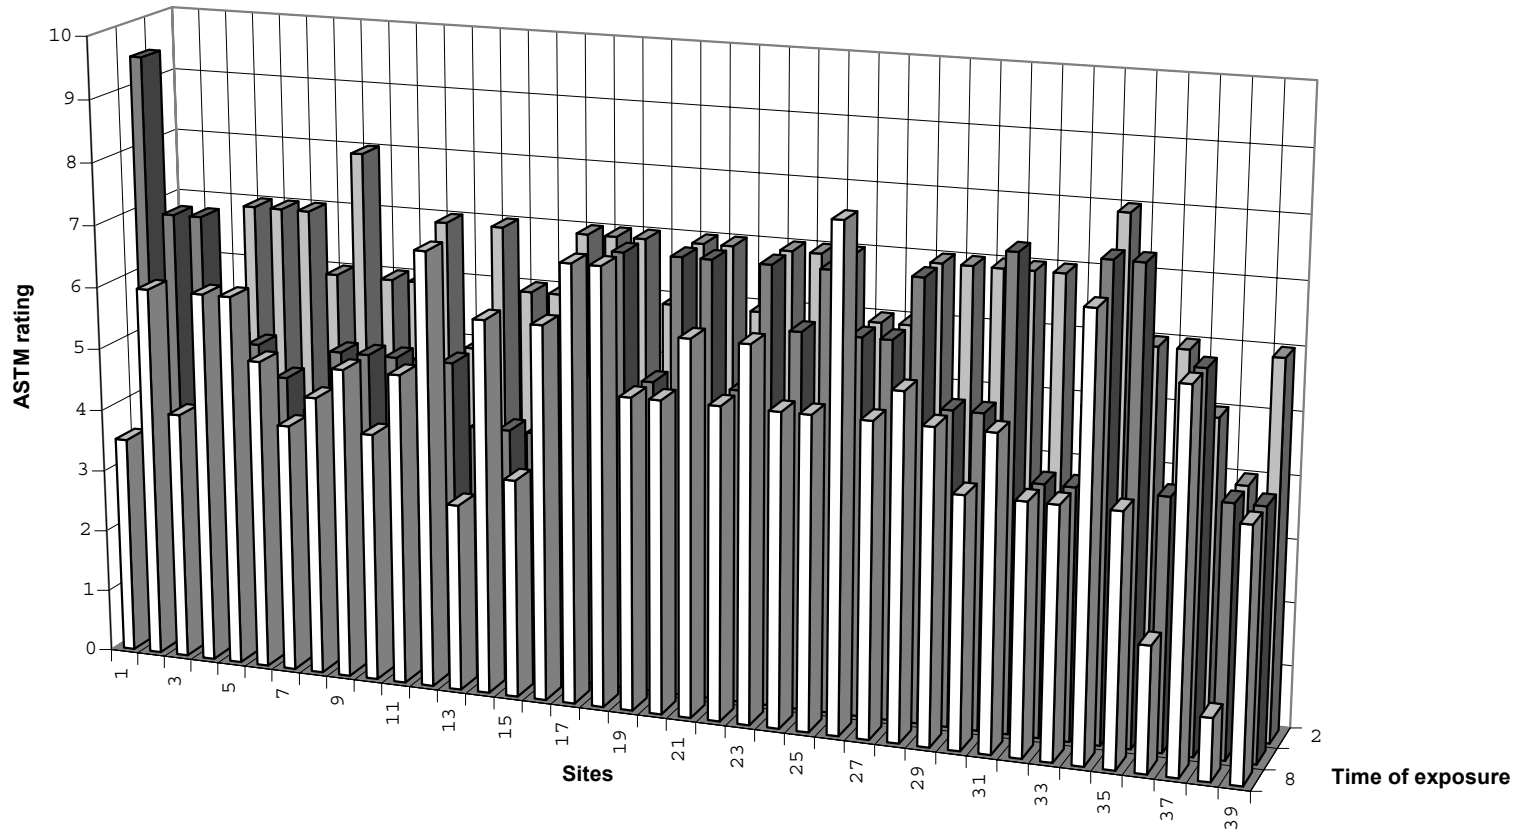
Figure 1.12: Type K. Chalking after 2, 4 and 8 years of exposure.

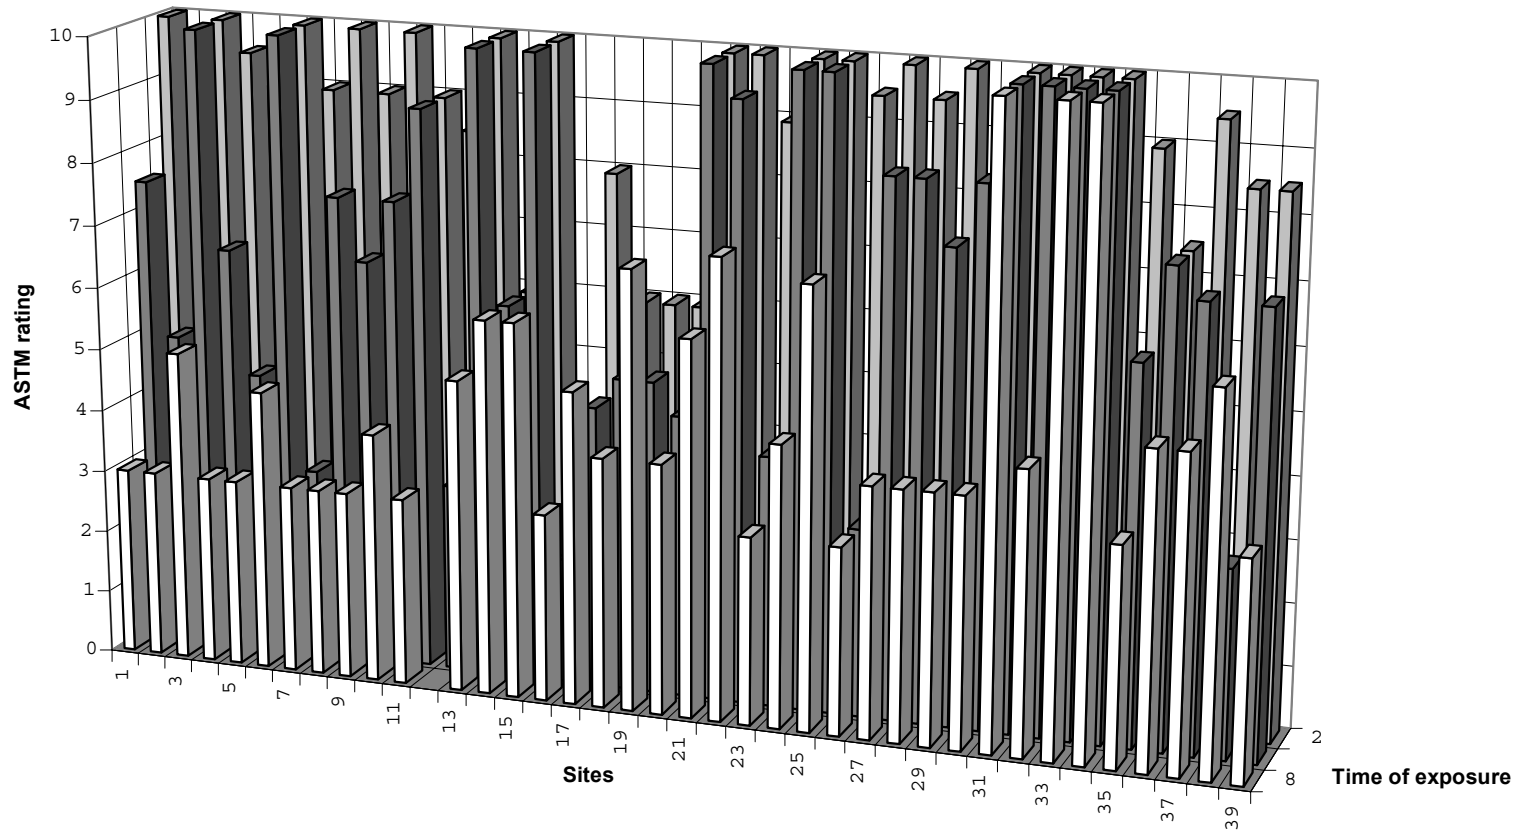
No fungus was found at the three sites SPA 31 and SPA 33 and RU 34.

Most fungus was observed at the sites in CZE, FIN and GER.

Figure 1.13: Type I. Fungus after 2, 4 and 8 years of exposure.

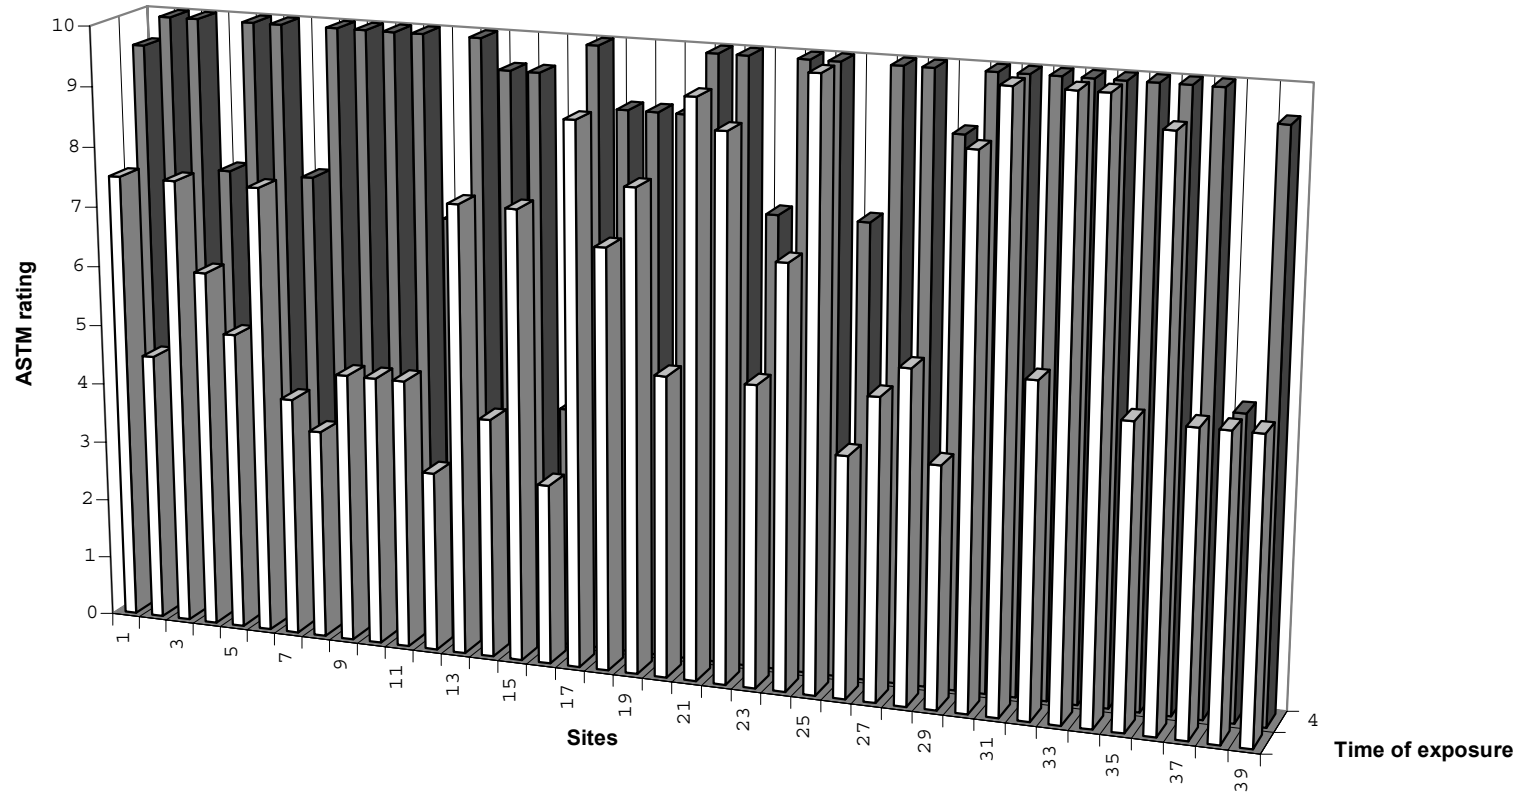
No fungus was found at these sites: SWE 25, SPA 31 and SPA 33 and RU 34. The three last ones are the same sites as for type I.

Figure 1.14: Type K. Fungus after 4 and 8 years of exposure.

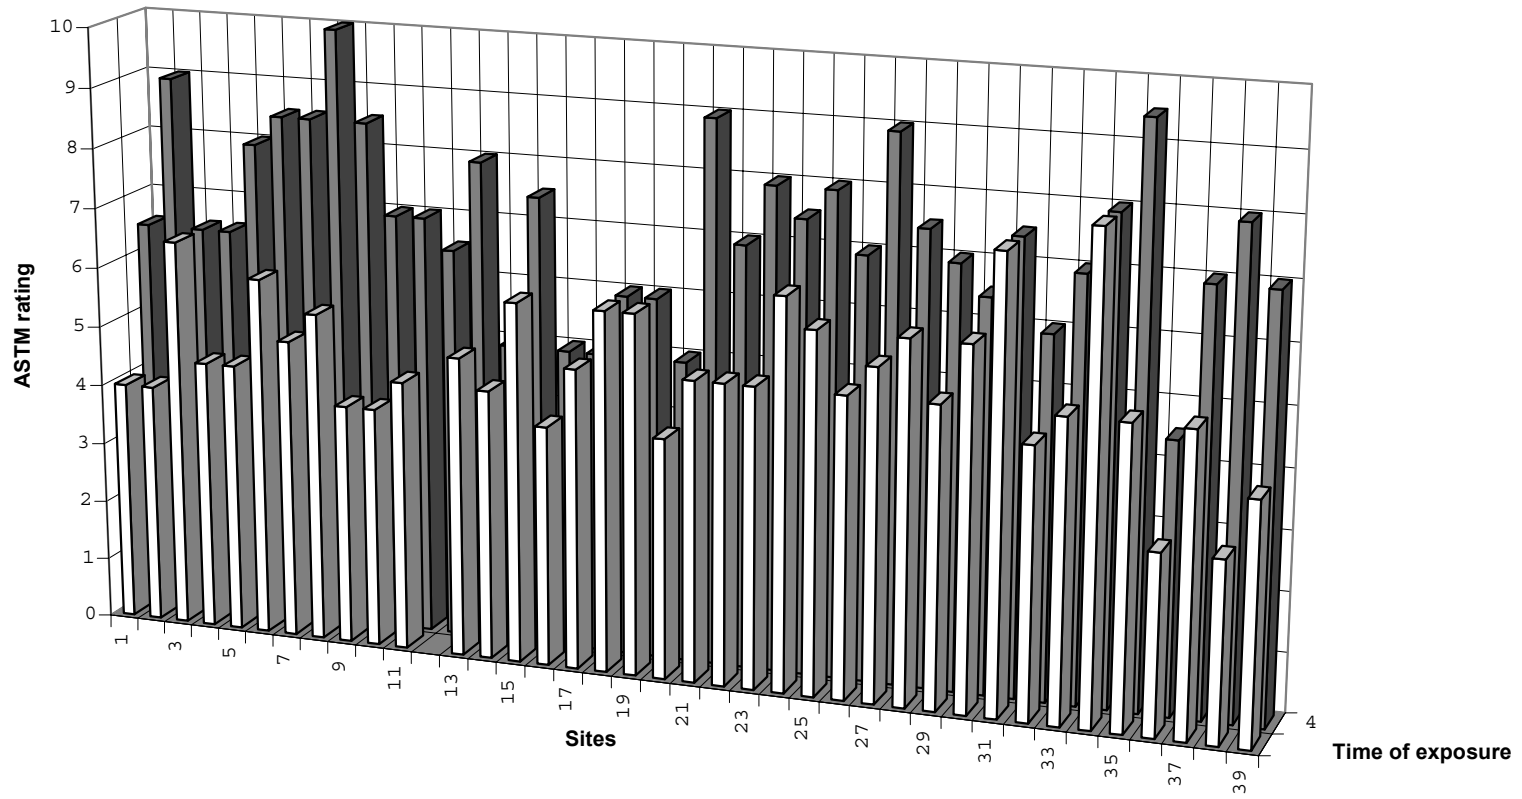
Cracking has developed fairly much the last four years, especially for the alkyd paint system. The alkyd system was also more affected to checking and development of sigmoid cracking forms, even if these forms also were observed on the acrylate paint system.

The panels at all the sites had cracking. Least cracking we observed at the sites RU 34 (RN = 8) and SPA 31 (RN = 7.5). At the site GER 8 the RN value had fallen from 10 to 5.5 from four to eight years of exposure, and for EST 35 was the corresponding fall from 9.5 to 5. The worst panel we found in the sites POR 36 and USA 38, both with RN = 3.

Figure 1.15: Type I. Cracking after 4 and 8 years of exposure.

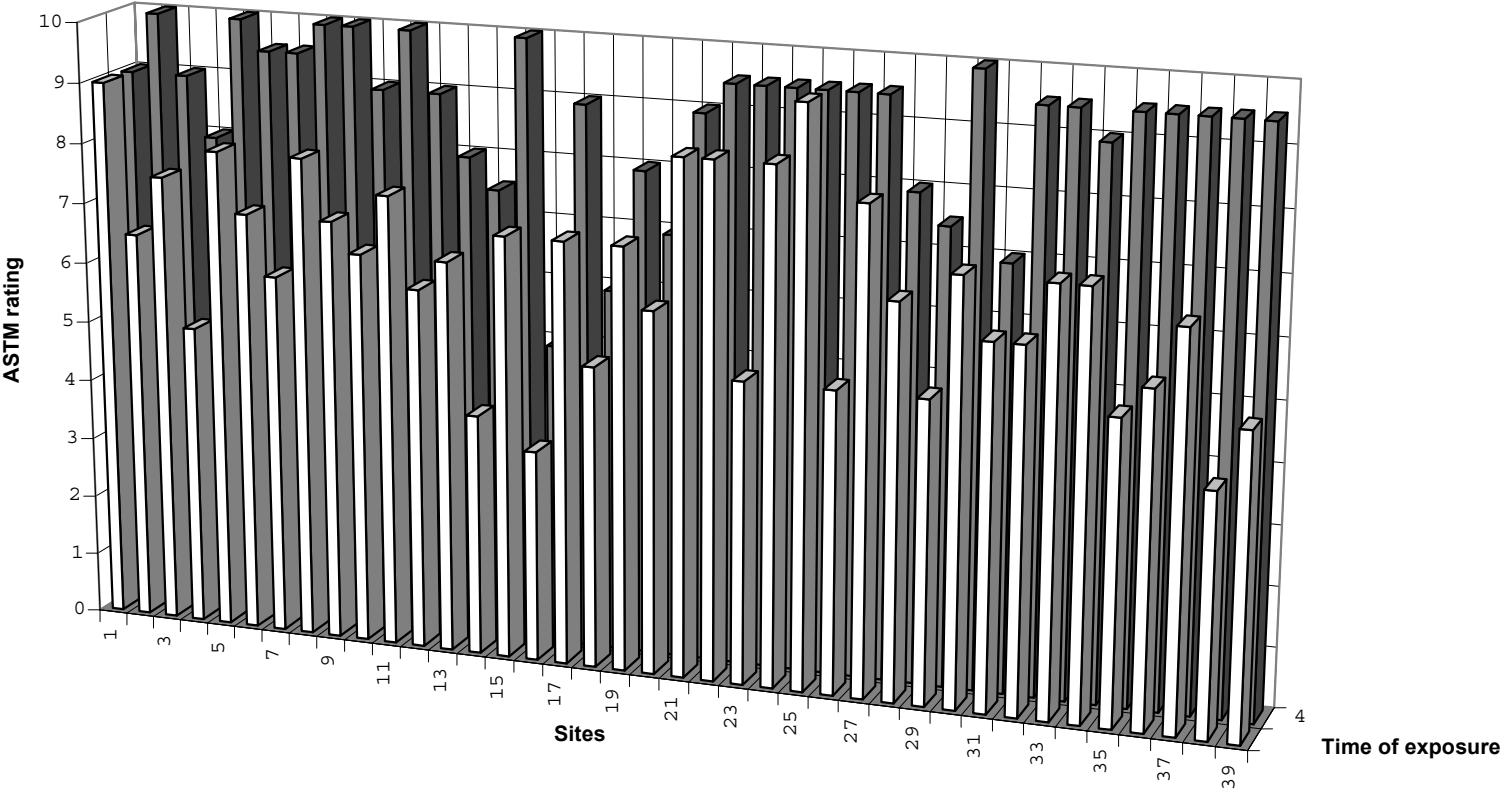
Also the acrylate paint system had some cracking, but less than alkyd.

The best score we got at the sites SWE 25 (RN = 9.5) and CZE 1 (RN = 9). NOR 21 and NOR 22 and SWE 24 had RN = 8.5. The worst panel we found in ITA 16 (RN = 3.5), but also USA 38 and ITA 14 were bad (RN = 4). In this connection it should be mentioned that RN of the panel in USA 38 had dropped from 9.5 to 4 the last four years.

Figure 1.16: Type K. Cracking after 4 and 8 years of exposure.
