UN/ECE INTERNATIONAL CO-OPERATIVE PROGRAMME
ON EFFECTS ON MATERIALS, INCLUDING HISTORIC
AND CULTURAL MONUMENTS

Results from the multipollutant programme: Corrosion attack on painted steel after 1, 2 and 4 years of exposure (1997-2001)

NILU: OR 34/2003
REFERENCE: O-8208
DATE: JUNE 2003
ISBN: 82-425-1460-7

Odd Anda and Jan F. Henriksen

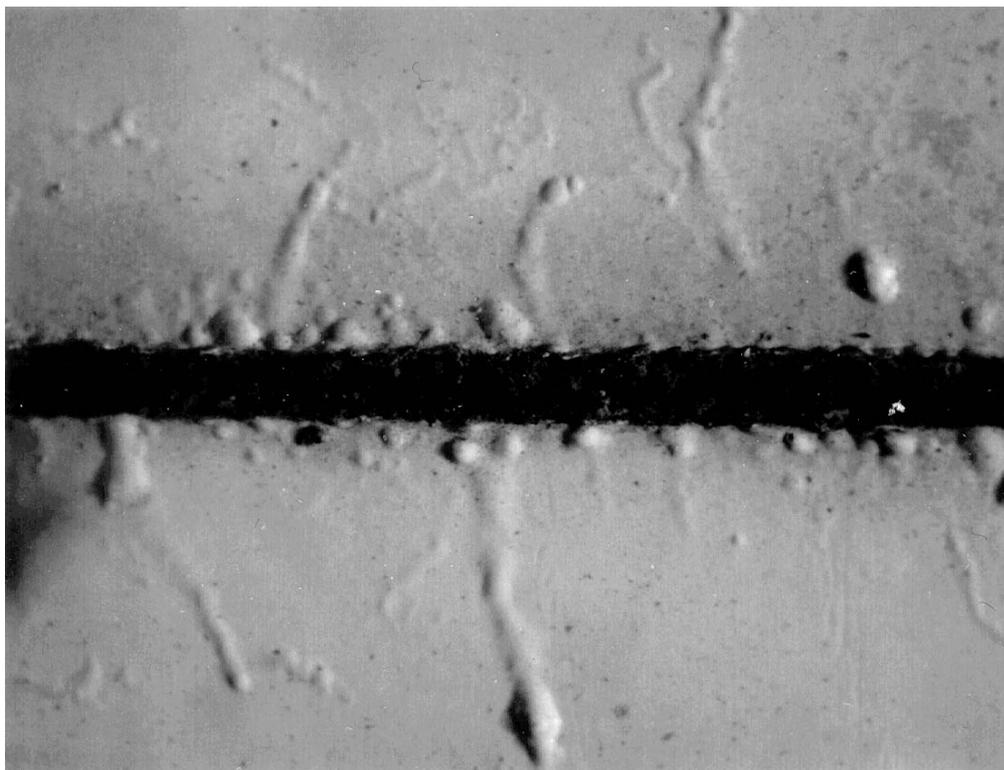
While flaking and blistering were the dominating form for damage in the first phase of the programme, filiform attack occurs more frequently in the second phase. Figure 2 shows a typical example of this type of attack taken from the two years of exposure at Lincoln Cathedral. Table 2 gives the results of filiform corrosion for the test sites and the evaluation technique used is illustrated in Figure 1.

Figure 2: Filiform attack from the cut on alkyd painted panels at site Lincoln Cathedral.

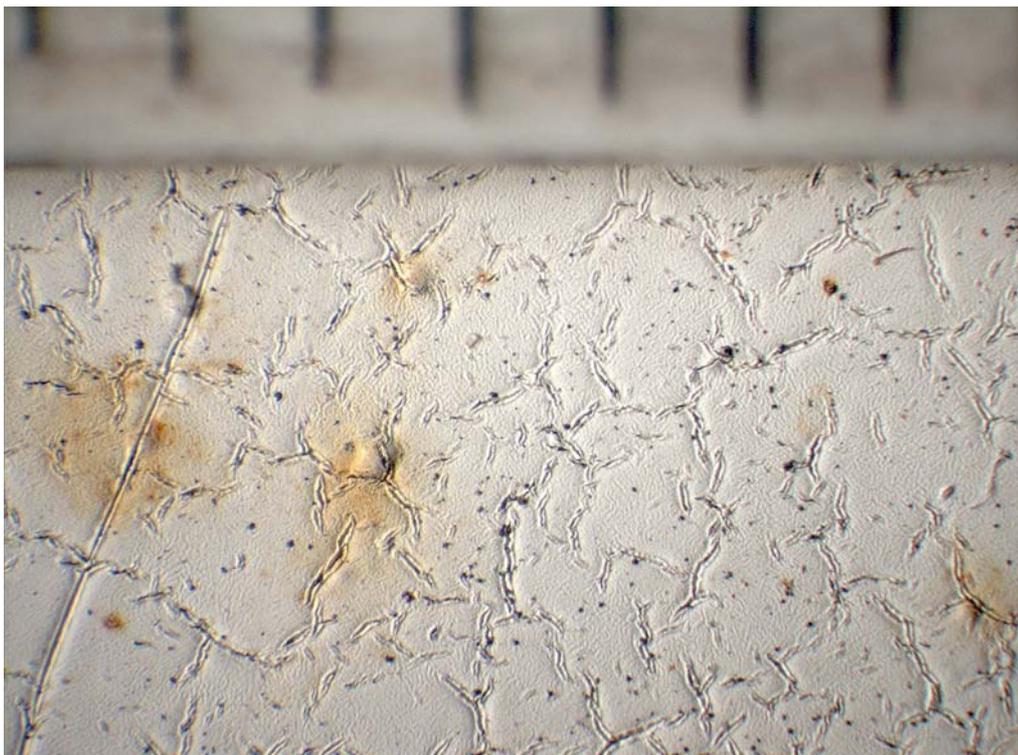
At several places the paint surface was cracked. For some of the sites it could be seen without a microscope. The worst cracked paint was observed on site 43 Tel Aviv. At that site the cracking went down to the steel substrate and the paint was spotted with rust coming through the paint film, see Figure 3-Figure 5.

Figure 3: The paint surface after four years of exposure at site 43 Tel Aviv.

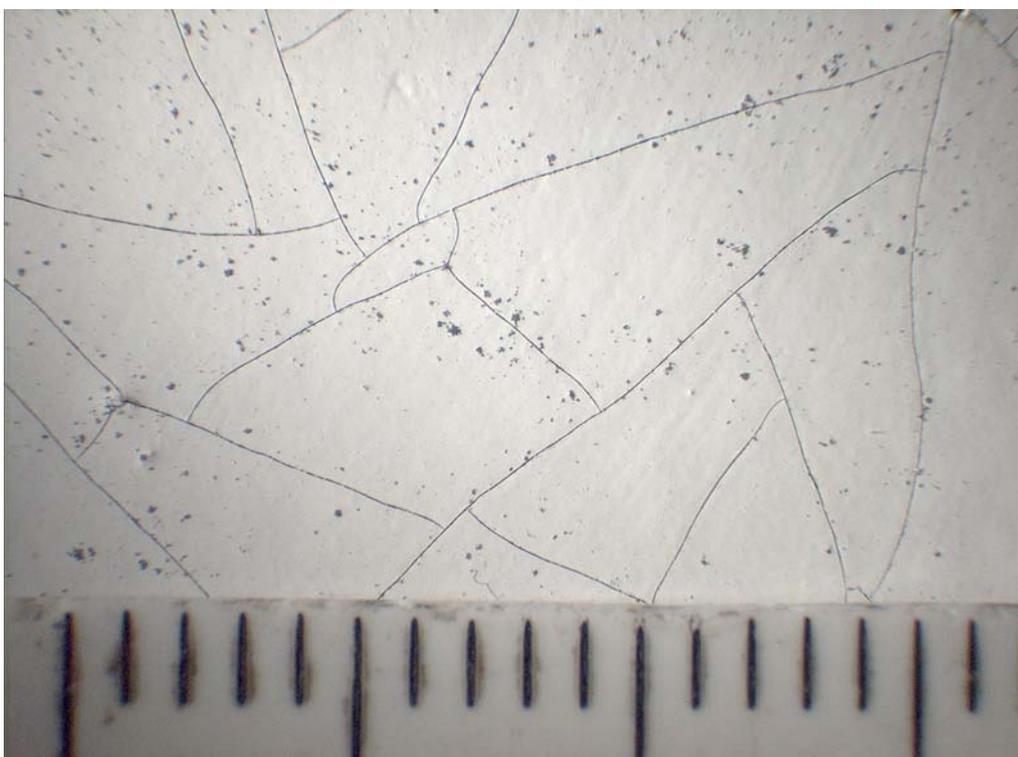
Figure 4: The paint substrate after four years of exposure at site 37 Dorset, Canada.

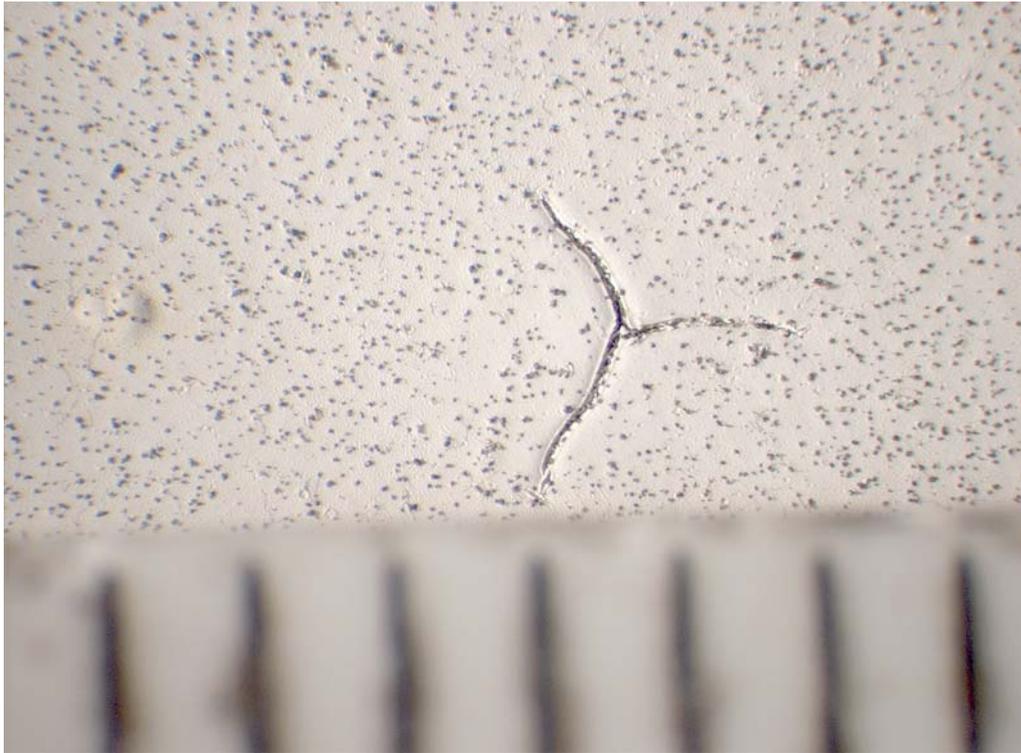
Figure 5: The paint substrate with cracks after four years of exposure at site 16 Venice.

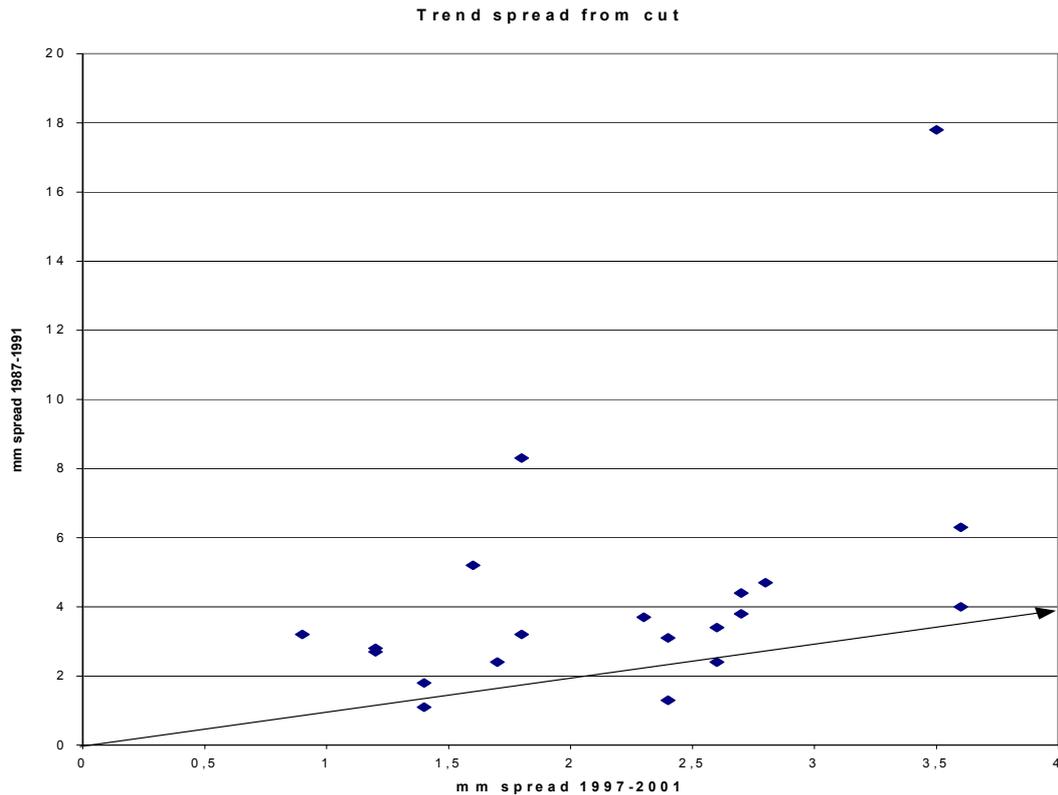
Figure 6: The spread in damage from cut after four years of exposure for the period 1987-91 against 1997-2001.

From the data in Table 4 and Figure 6 it is obvious that most sites have had a positive trend for the last ten years. A slight change to more corrosion is observed on the sites 27 Lincoln Cathedral, site 33 Toledo and site 36 Lisbon. Particularly the sites with high attack in the first phase have got the largest reduction.
