DIVISION BUILT
ENVIRONMENT
WOOD CONSTRUCTION
TECHNOLOGY

Experiences from the Deconstruction of a Timber Building

RISE Report : 2022:09

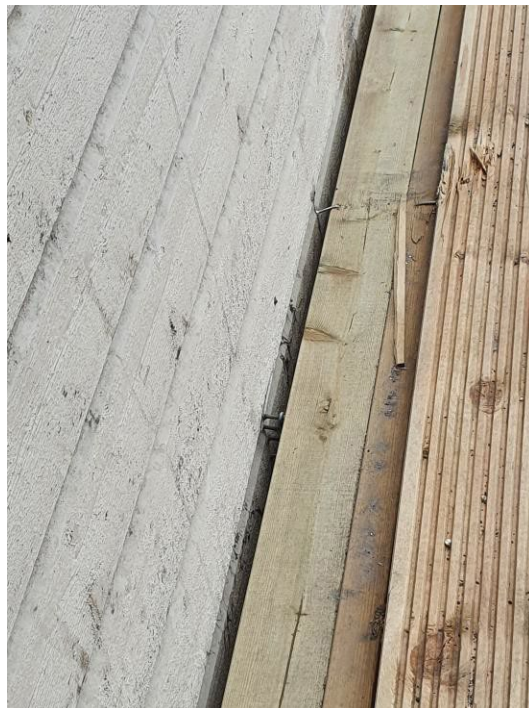
An experience from this project is that it should be clear which attachment points that are to be used and how many screws that should be used for each point of attachment. For the original assembly, it should be clearly prescribed how much screw that is allowed to be used.

Figure 6 - Example of excessive use of screw; here in attachment of access balcony to apartment module.

- For the original assembly, the amount of screw allowed should be clearly described.
- For deconstruction, it is advantageous if the number of attachments is limited.

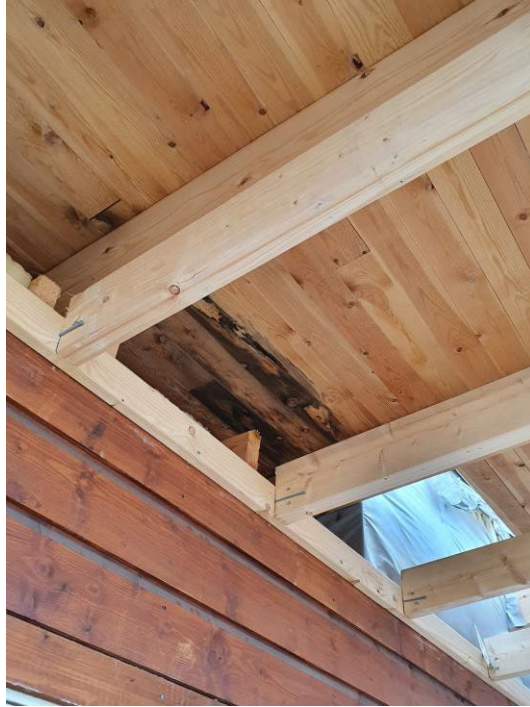
Figure 7 - Moisture damage to the roof of the staircase/ access balcony.

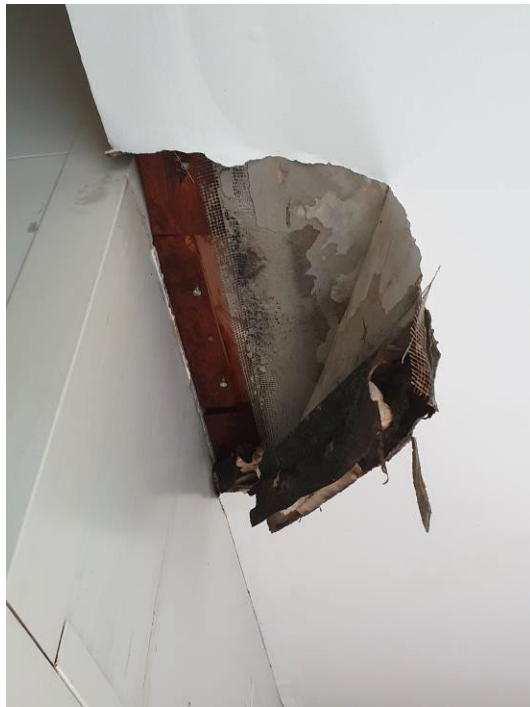
Figure 8 - Moisture damage in staircase ceiling.

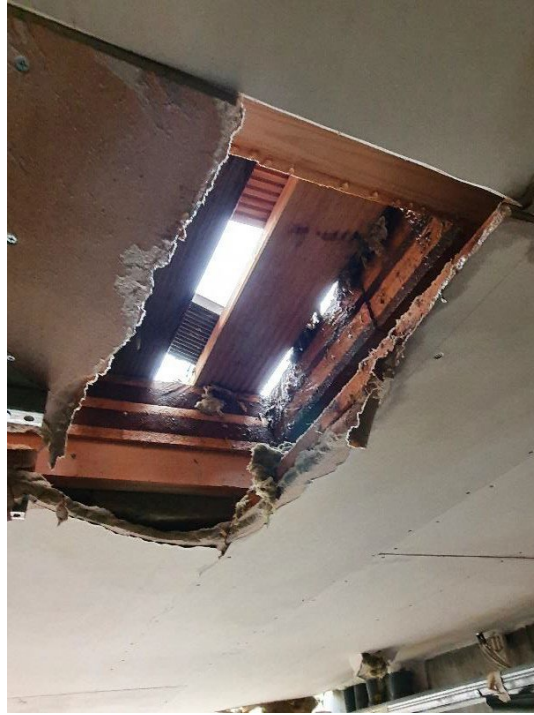
Figure 9 - Moisture damage in staircase ceiling.

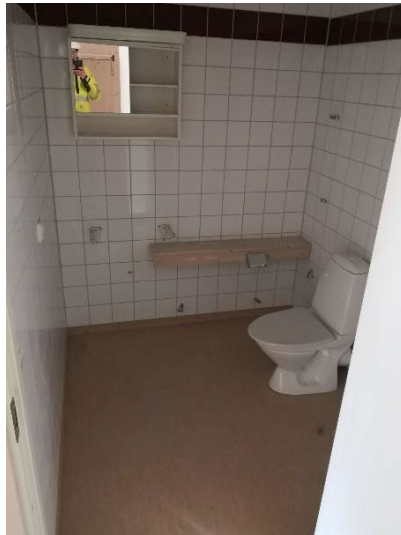
entered the apartments and stole shower mixers and mixer taps for the sink. In many apartments, this has created consequential damage to sinks that were simply crushed to get rid of their mixer taps as well as damage to bathroom walls where the shower taps were installed.

Figure 12 - Bathroom in apartment. Sinks, pipes, and mixer taps were stolen from all apartments in connection with a burglary.

One experience to take away from this is that one should consider the risk of burglary, theft, and those consequential damages these may cause.

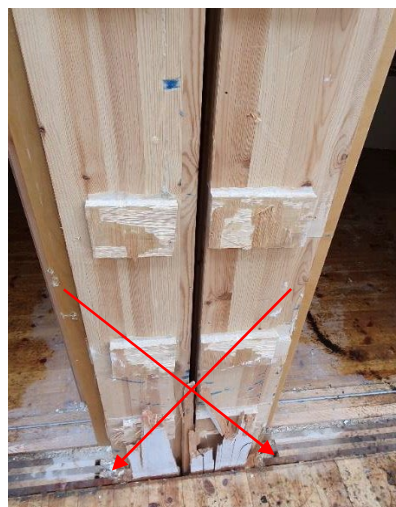
Figure 13 - Joint between two apartment modules. The arrows illustrate how the modules were screwed together, which made deconstruction more difficult.

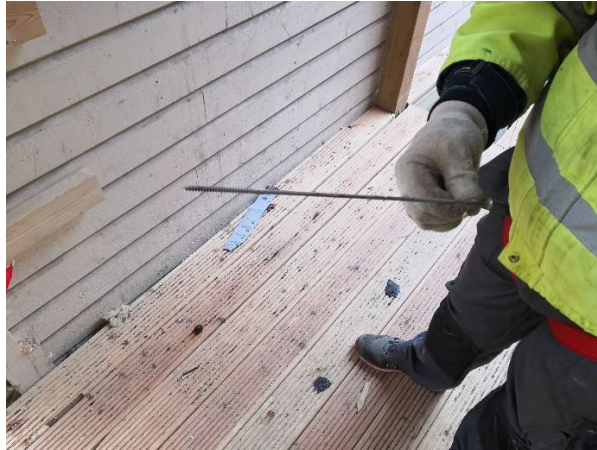
Figure 14 - Example of long screw, used when the modules were screwed together.

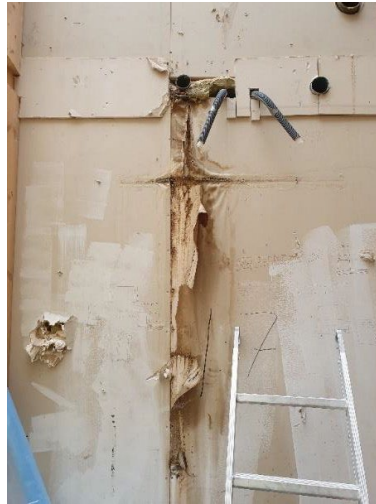
Occasional local moisture damages were noted at pipe connections. Probably these have arisen in connection with the dismantling of pipes and the discharge of standing water. Our view is, however, that the local moisture stains that were noted on gypsum boards can be easily remedied by replacing the damaged paper of the gypsum plaster board. Some of the moisture damages could probably have been avoided if the pipes could have been emptied of water in advance and the pipes could have been more carefully deconstructed.

Figure 15 - Moisture damage around pipes that were cut in connection with disassembly.

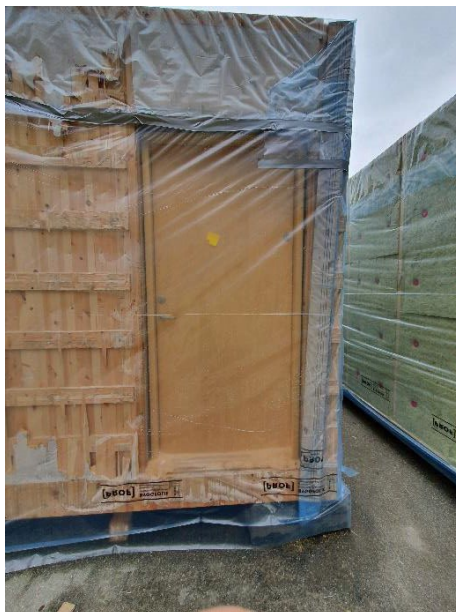
Figure 19 - Risk of moisture problems when the modules are covered with plastic (already condensation on the inside).

The modules must be protected from rain and snow during any intermediate storage. No matter how the modules are stored, it is probably beneficial to have as short a storage time as possible. If the modules are stored wrapped in shrink plastic (as during transport) there is a risk that one gets an unfavourable climate inside from a humidity point of view at least if they are stored in sunlight. It is recommended that you check the climate in the modules during storage and use dehumidifiers if necessary.

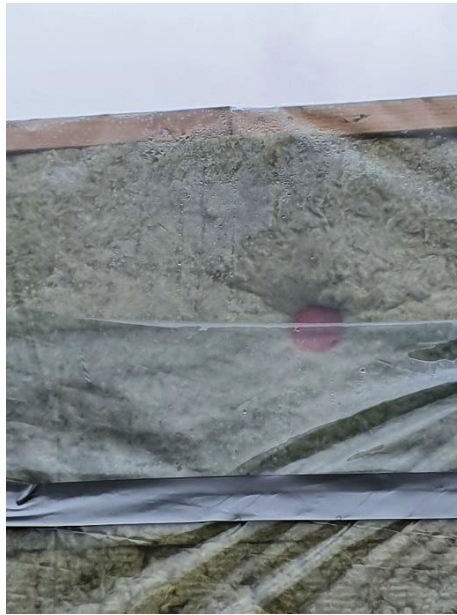
Figure 20 - Condensation inside the plastic.

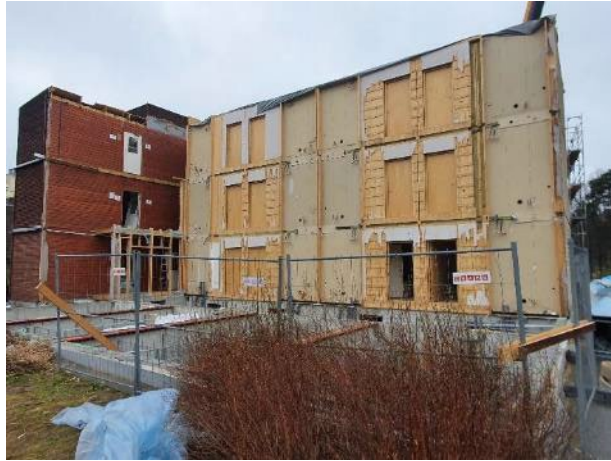
Figure 22 - At the time of our investigation, there was no plan for the basement structures after dismantling.
