Comparison of two test methodologies for fire testing of façade systems

RISE RAPPORT 130011-08B
Mikael Bergius

RISE rapport 2023:29 ISBN 978-91-89757-75-2 Project number: 130011-05B

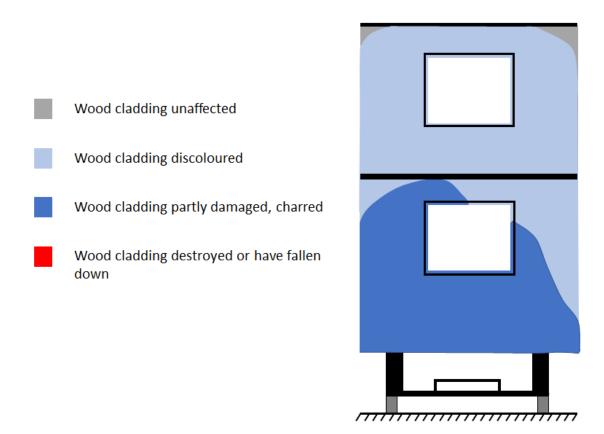
Figure 3-35 Fire damage of the surface of the façade after the test according to SP Fire 105.

- 1. Drip cap at lower fictious window was deformed on the left side.
- 2. Charing of the cladding did not reach further up than at the mid-section flashing.

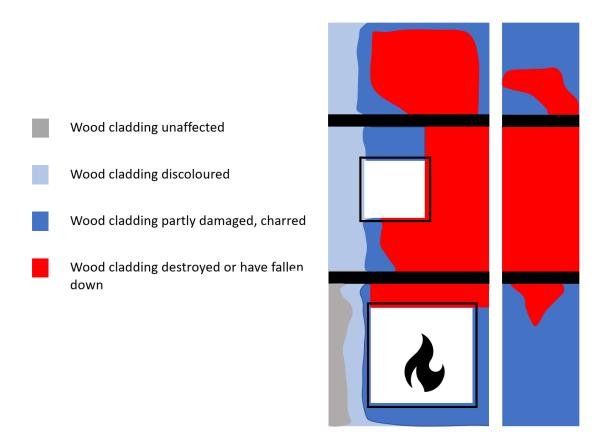
Figure 3-36 Fire damage of the surface of the façade after the test according to the draft proposed European method

- 1. Cladding and insulation have fallen off the middle part of the main wing from the combustion chamber and all the way to the top. Some cladding was remaining towards the left side of the main wing.
- 2. Cladding and insulation on the return wing have fallen off from half the height of the combustion chamber all the way to the top. Some cladding was remaining on random locations.

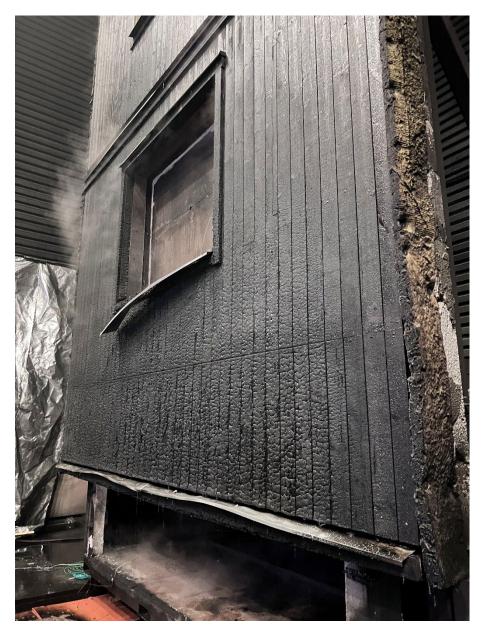
Photo A- 2 Close up of the lower part of the test specimen after the test.

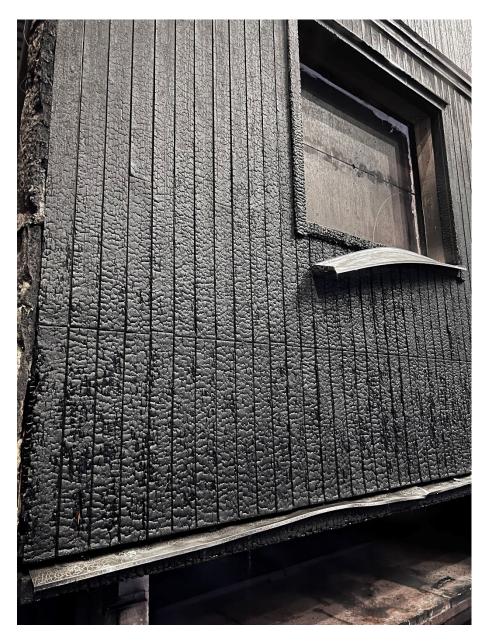
Photo A- 3 Close up of the lower part of the test specimen after the test.

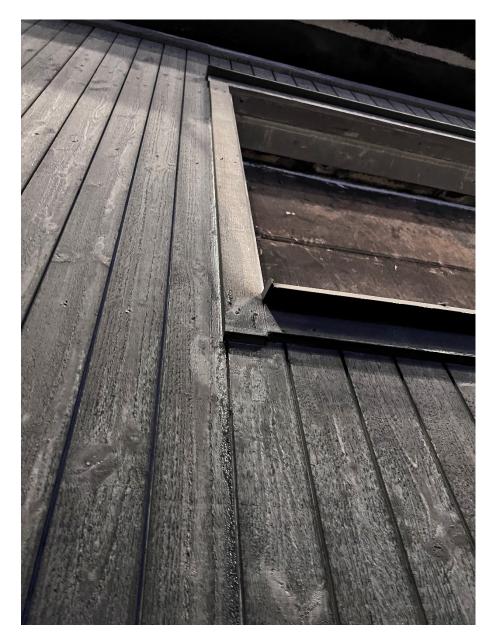
Photo A- 4 Close up of the upper part of the test specimen after the test.

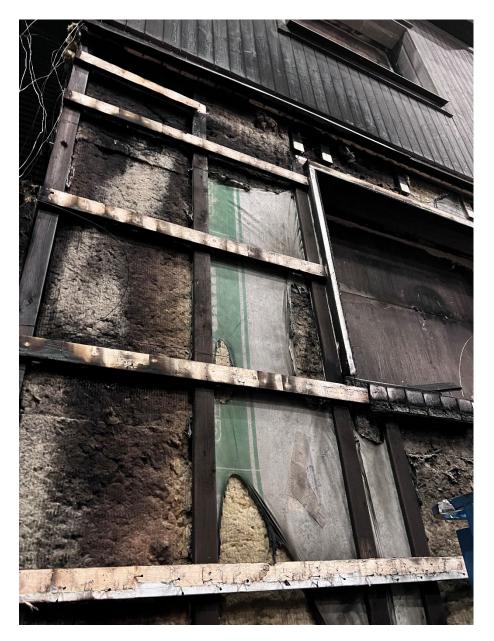
Photo A-5 Close up of the lower part of the test specimen with the cladding removed.

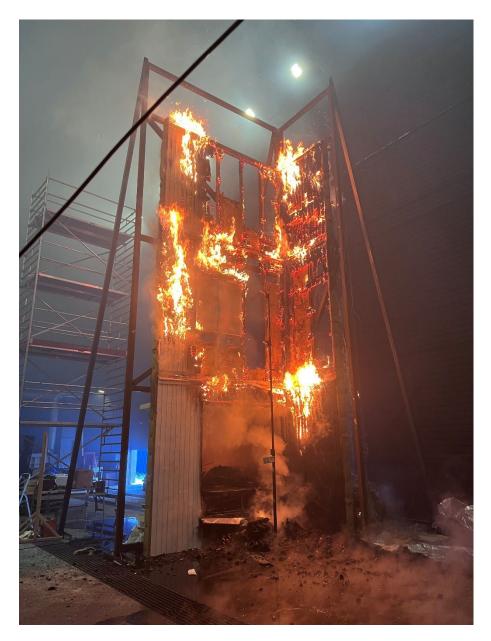
Photo B-8 Overview of the test specimen after the crib has been extinguished.

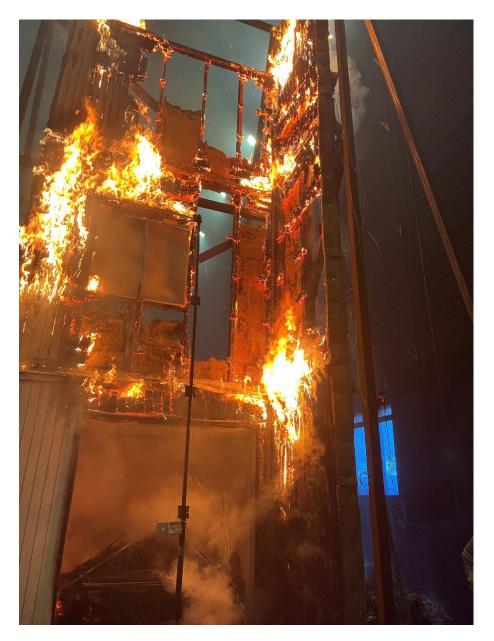
Photo B-9 Close up of the test specimen after the crib has been extinguished.

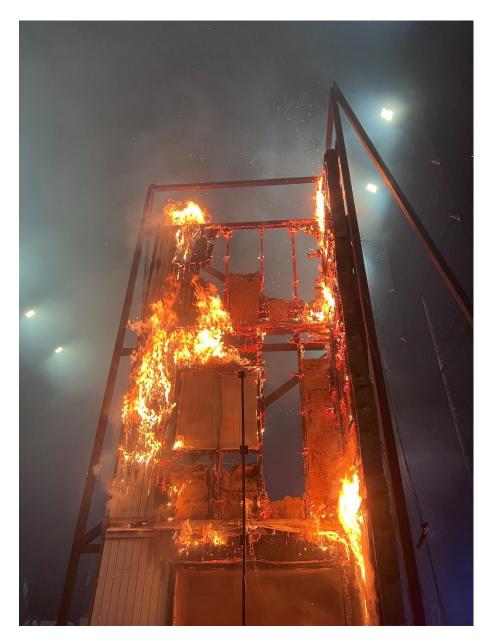
Photo B-10 Close up of the upper part of the test specimen after the crib has been extinguished.
