EVALUATION OF SNOW REMOVAL METHODS FOR ROOFTOP PHOTOVOLTAICS

*Alexander Granlund, Mattias Lindh, Tommy Vikberg, Anna Malou Petersson
RISE Research Institutes of Sweden AB, Industrigatan 1, 941 38 Piteå, Sweden

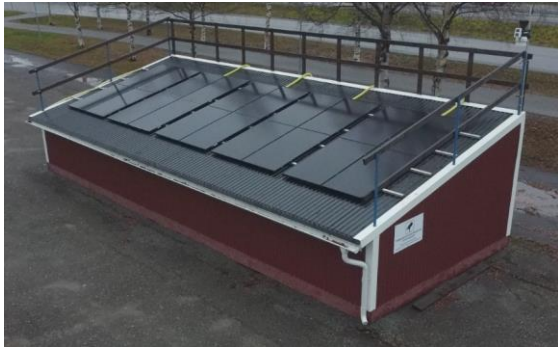
Figure 1. The test facility in november 2021. Module groups from left to right: heated, coated, control, roof rake with slide, and rectangular roof rake.

The test facility, presented in Figure 1, is located in Piteå, Sweden, at 65°N; where the snow depth on average

peaks at 70 cm each winter and roofs are built to withstand a snow load of 3 kPa [15], [16]. The test facility consists of a 12 m × 5 m construction with a 14° single pitch corrugated steel roof. A low inclination was chosen to promote snow accumulation and represent an installation where snow removal might be necessary. The roof was fitted with 20 framed monocrystalline glass/backsheet 60-cell PV-modules (*Longi LR6-60BP 305M*) divided into five equal groups mounted on a rail and clamp system (*Schletter Solo* and *Rapid*). The modules had a mechanical load rating of 5.4 kPa according to *IEC 61215*. Four of the groups were designated snow removal methods, whereas the centre group was the control. Cable connections were accessible from within the facility, enabling on-site electroluminescent (EL) imaging. The modules were stored at open circuit as mechanical degradation was the focus of this study. Time-lapse images were recorded with a surveillance camera throughout the second and third winter (*Reolink Go PT*).

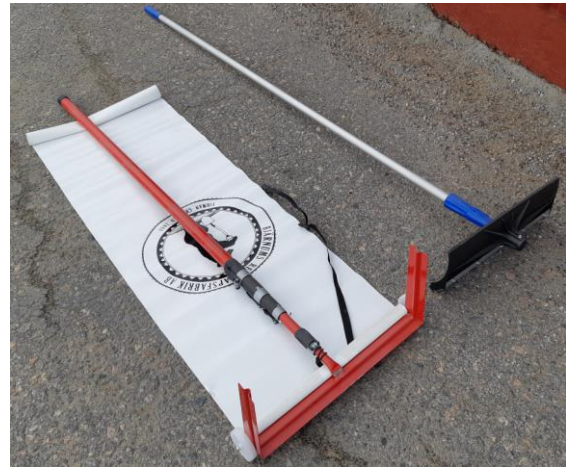
Figure 2. The two roof rakes.

For this study two different toolheads were tested. One was designed to be pushed up from the roof eave through the snowpack and cut out blocks of snow. The blocks would then slide down a plastic tarpaulin off the roof. The steel toolhead was mounted on plastic wheels to keep some distance between the it and the underlying surface. The other rake featured a simple rectangular toolhead in hard plastic designed to pull and scrape down snow off the roof. One long edge was fitted with less abrasive cell foam. The toolhead must be lifted above the

snow and lowered with sufficient force to grab it, before pulling it off the roof. Both roof rakes are presented in Figure 2.

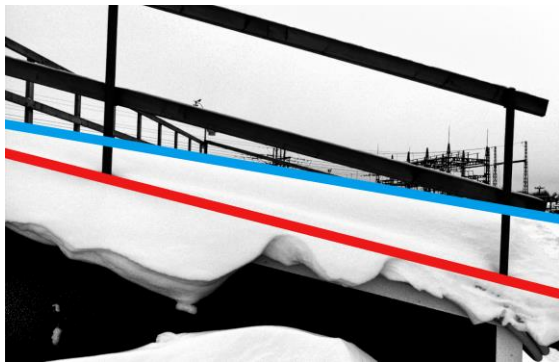
Figure 3. Blue, snowpack inclination; red, roof inclination.

The single-pitch roof typically accumulated snow unevenly. Less snow gathered along the top and sides, meaning that the thickest part of the snowpack typically was slightly above the eave at the centre of the roof. An example of how the snowpack thickness varied along the height of the roof is presented in Figure 3.

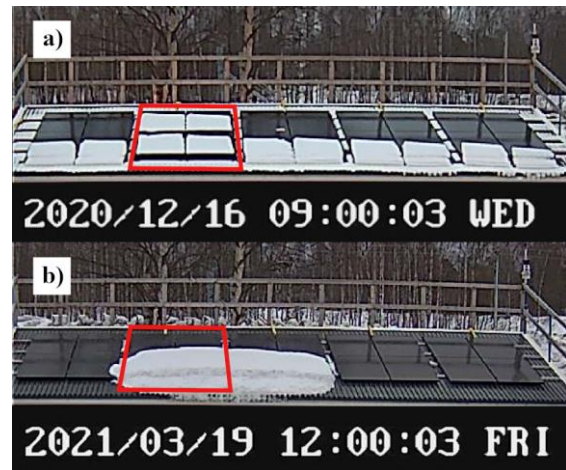
Figure 4. Coated SoliTek module group marked with red. a) Module frames likely preventing snow shedding. b) Snow still covering parts of the coated and control groups at the end of winter.

The coatings tested in this study did not indicate any decrease in snow accumulation or increase in snow shedding performance compared to the control group. The second set of coated modules performed worse in terms of snow accumulation and shedding, which was likely not due to the coating itself but rather the sharp edges of the frame-edge where it meets the glass, compared to the Longi modules. For the SoliTek modules, that edge was a sharp right angle protruding 2 mm from the glass surface, for the Longi modules the edge also protruded 2 mm but featured a smooth curved edge. Figure 4a shows an occurrence when the frame likely inhibited snow shedding and Figure 4b the end of one winter where the coated modules (*SoliTek*) showed no distinct difference from the control modules.

The snowpack seemed to remain on the PV-installation for several different reasons. Snow on the roof eave below the modules might hinder snow shedding, as seen on the control module group in Figure 4b, likely due to more friction on the roof than the modules. Figure 5 indicates that this alone cannot explain why shedding did not occur for thicker snowpacks. The relatively small module groups as compared to typical PV-installations gives a proportionally large circumference relative to the area. This means that edge effects from frames, rails and neighbouring snow – that the snowpack can cling to – might have a larger than typical impact when the snowpack is thick enough to drape over the module groups' edges. Throughout thaw-freeze cycles these effects will likely grow more prominent. Figure 6 shows that once the snowpack was separated from these points of attachment, snow shedding could occur for the heated group. Lastly the frame edges also affect snow remaining on the PV installation through obstruction, as seen in Figure 4a, where the sharp edges of the SoliTek modules' frames are believed to prevent snow shedding.

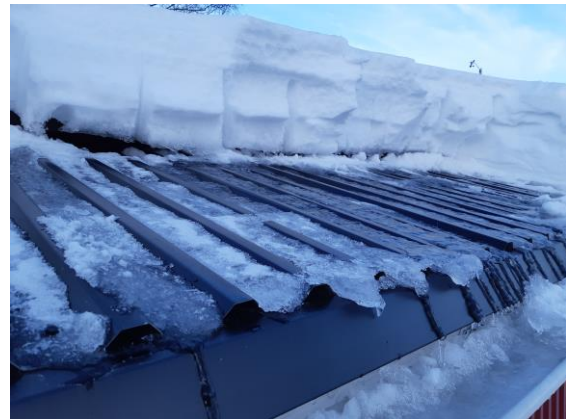
Figure 5. Snow unable to shed after 6 hours of heating with no snow on the roof eave.

hours, unless all snow was removed, what meltwater remained in the snowpack would refreeze. To isolate factors that might have prevented shedding, other than the low inclination, the snow on the eave below the modules was removed as seen in Figure 5. This was done on multiple occasions, and in this case, after 6 hours of heating, the snowpack still showed no signs of shedding.

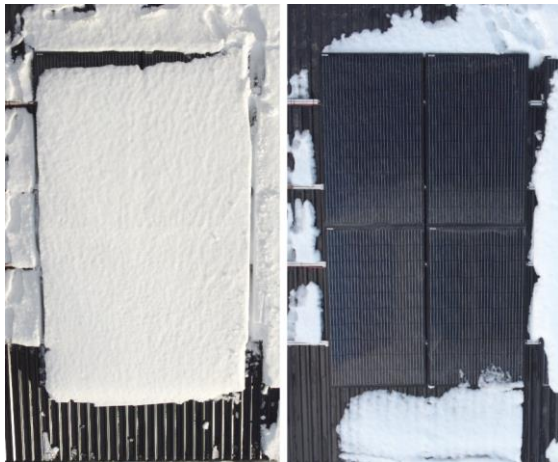
Figure 6. March 2nd, 2022, the ambient temperature ranged between +4–7°C. Left, snowpack separated from anchor points prior to heating. Right, successful snow shedding after heating.

On two occasions the snow cover was also cut along the side edges of the module group, which enabled snow shedding as seen in Figure 6. The ambient temperature was on this occasion above melting. Thus, shedding was found to be possible under certain circumstances.

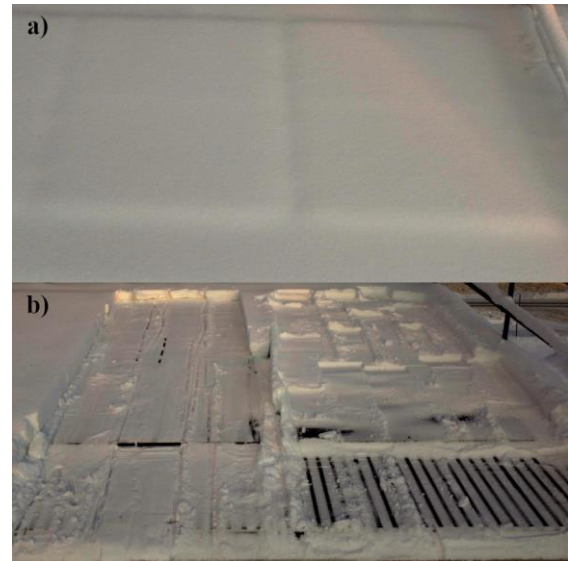
Figure 7. a) The roof rake groups prior to snow removal on December 15th 2021 and b) after snow removal. Left group, roof rake with slide, and right group, rectangular roof rake. Snow was dry and wind packed.

Both types of tested roof rakes could often remove most of the accumulated snow from their respective group. The roof rake with a slide did not completely remove snow due to the gap between modules and toolhead formed by the plastic wheels. The wheels and general design did however make it easy to use in most cases, but certain types of snow proved problematic. This included when snow was loose and grainy, very icy, or wet and compact. These conditions made it problematic to get the toolhead underneath the snow cover, especially with a fully extended telescopic handle, and very icy crusts made it difficult to cut through the snow. The rectangular roof rake also struggled in certain conditions. Dry and wind-packed snow often adhered especially well to the glass surface of the modules, which increased the required effort for snow removal markedly, especially with a fully extended handle, see Figure 7 for an example of performance in such conditions. Both methods struggled with snow that had experienced multiple thaw-freeze cycles and had icy crusts. The roof rake with a slide removed the snow without exerting significant stress on the modules. On the other hand, the long handle in combination with the weight at the toolhead of the rectangular roof rake made it difficult to handle and increased the risk of damaging the modules. In one case, the tool head was hence dropped above a module, resulting in a cracked cell wafer, see Section 3.5.

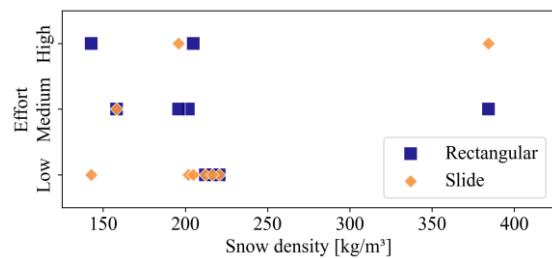
Figure 8. The effort required to remove snow of different densities with the two roof rakes.

Figure 8 presents the experienced effort required for snow removal at different snow densities. At high snow densities, when the snow is very wet, the rectangular roof rake required less effort since the snowpack more easily slipped downwards at these conditions, whereas the slide roof rake was difficult to force through the dense snowpack. At lower snow densities, the slide roof rake in

general required less effort.

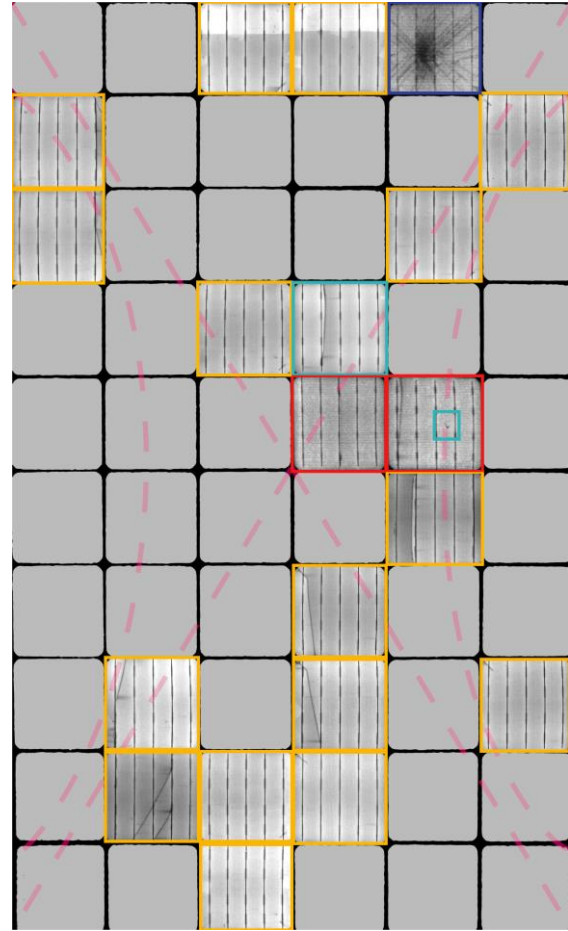
Figure 9. Superposition of cracked cells on a 60-cell module. Orange, surface coated (*SoliTek*); red, electrical heating; light blue, control; dark blue, rectangular roof rake. Dashed lines represents the typical X-pattern for cracks formed by mechanical loads.

As previously mentioned, snow removal with the rectangular roof rake caused an entirely cracked cell. No further cracks were detected on any of the modules belonging to the roof rake groups. The modules of the lower row of the other groups did however all have cracks. They show a slight tendency of following an “X-pattern”, which is associated with load related cracks [19]. The cracks imaged with EL in May 2022, their module group, and their relative position superimposed on a 60-cell module is presented in Figure 9 along an outline of the X-pattern. Cells in the coated modules (*SoliTek*) show crack formation with similar origin points for multiple cells, implying that these might be manufacturing defects that have remained undetected until they propagated to a noticeable degree. As mentioned, these modules are rated for a load of 3.6 kPa compared to 5.4 kPa for the other modules (*Longi*),

which might also explain why more cells from these modules are cracked.

None of the cracked cells, except for the cell damaged by the rectangular roof rake, give rise to dark isolated areas, and might hence not significantly affect the modules' energy output at this point. The cracks might however be likely to grow larger throughout subsequent winters and mechanical load cycles.
