NILU : OR 42/98  
REFERENCE : O-8208  
DATE : AUGUST 1998  
ISBN : 82-425-1000-8

**International Co-operative  
Programme on Effects on Materials,  
including Historic and Cultural  
Monuments**

**Evaluation of decay of painted systems for wood,  
steel and galvanized steel after 8 years exposure**

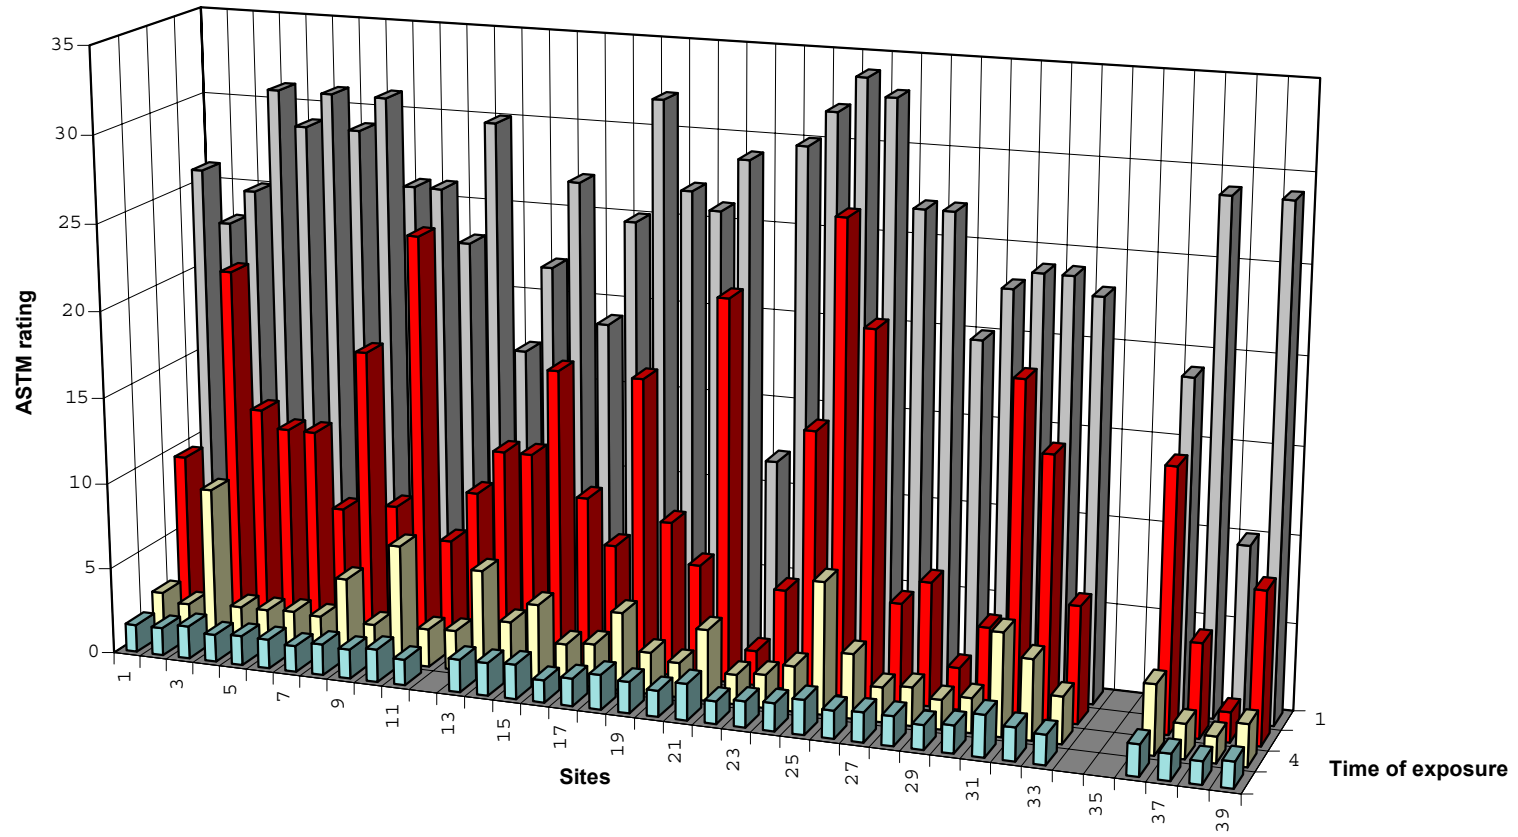
The results are given in Figures 1.7 and 1.8 (Annex 1), and in the Tables 2.2 and 2.3 (Annex 2). The measurements referred to have been made on unwashed surface.

Figure 1.7: Type G. Gloss after 1, 2, 4 and 8 years of exposure.

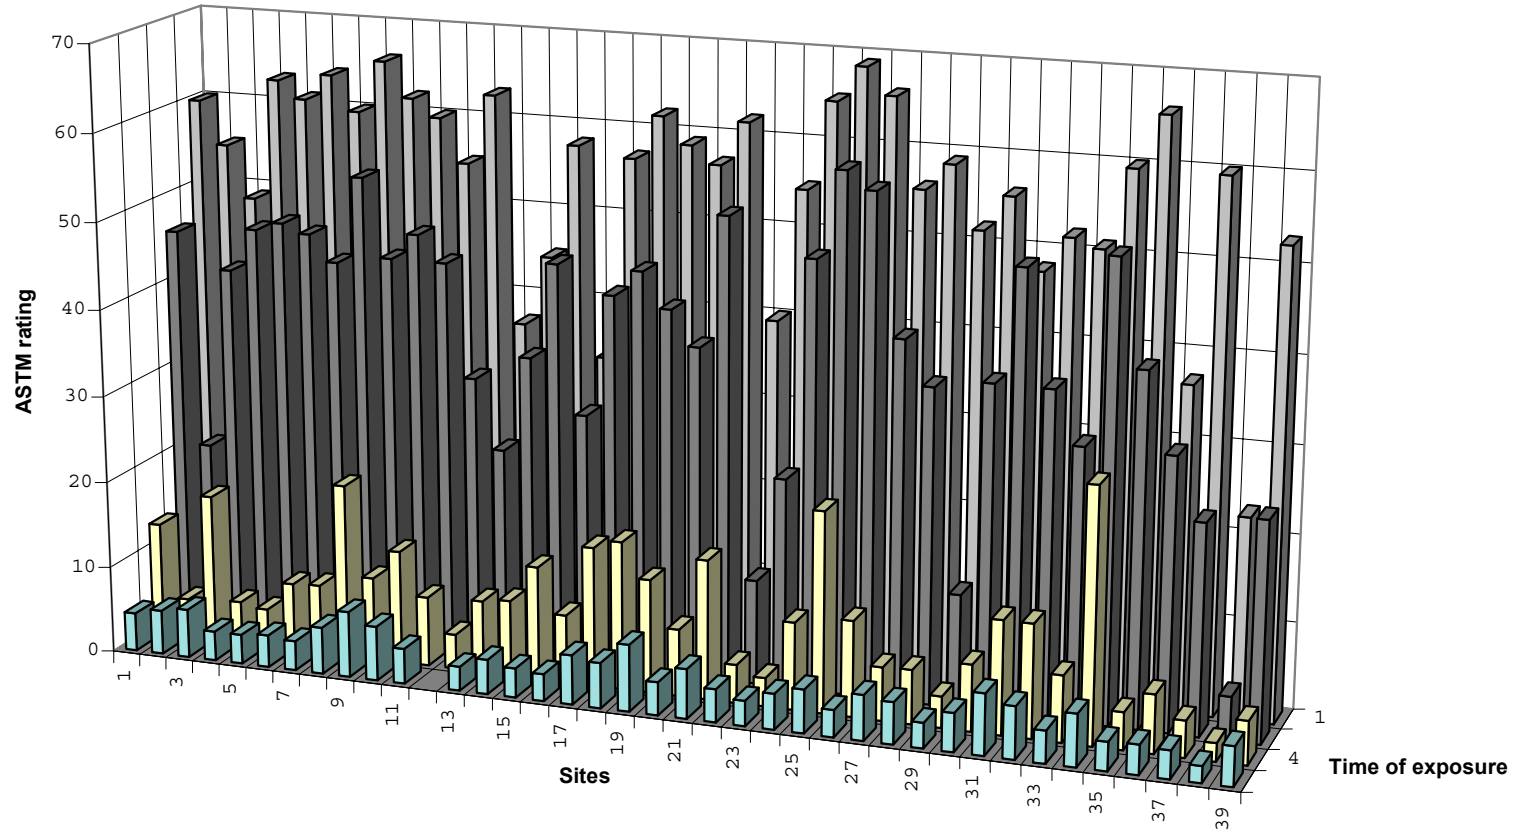
Figure 1.8: Type H. Gloss (front) after 1, 2, 4 and 8 years of exposure.

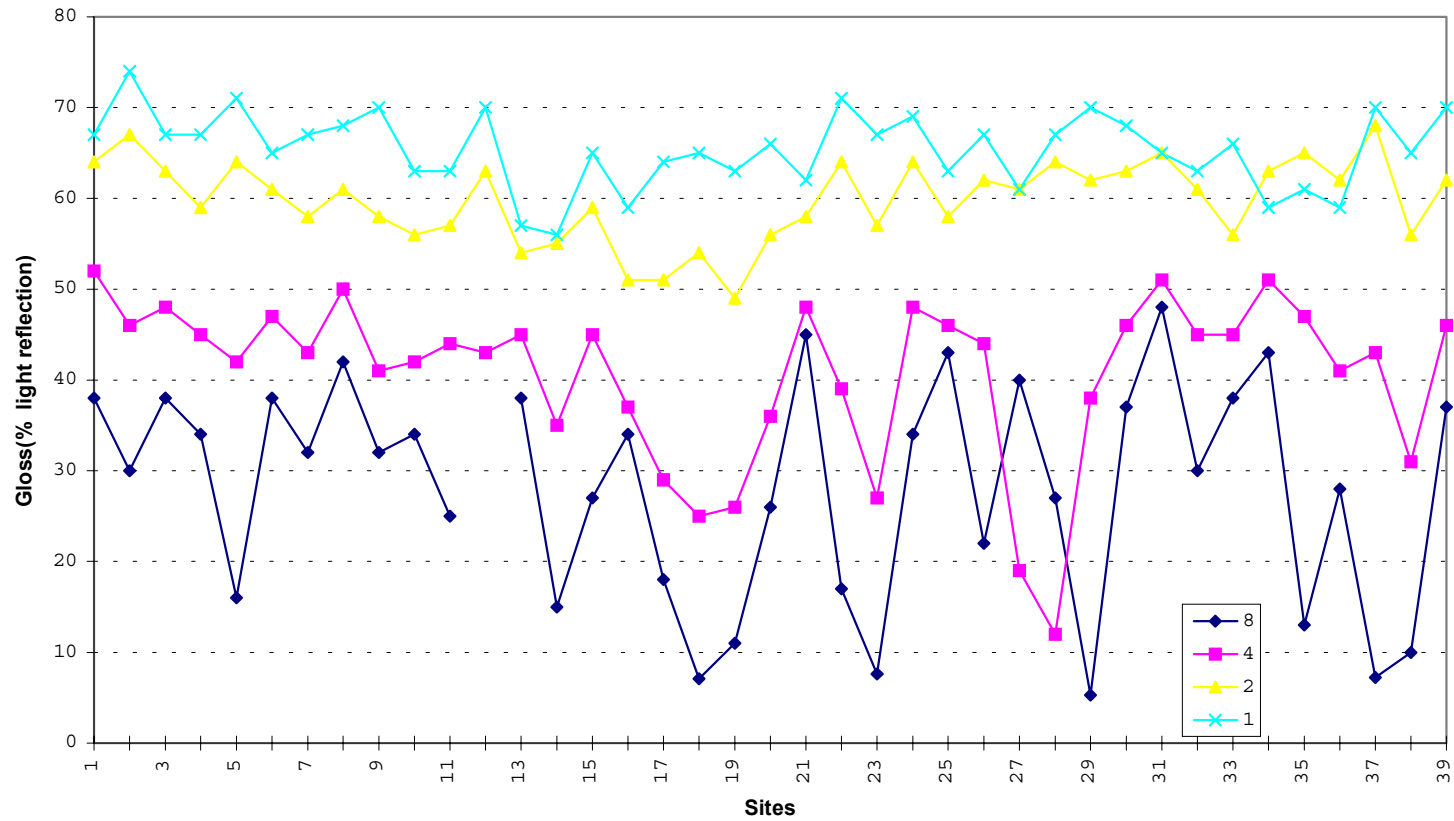
The panels with alkyd paint were even measured on the backside. The result is shown in Figure 1.9 (Annex 1) and in Table 2.3 (Annex 2). The values are as expected much higher because of the protection against sunshine and dirt contamination.

Figure 1.9: Loss of gloss on the backside of the alkyd painted panels after 1, 2, 4 and 8 years of exposure.

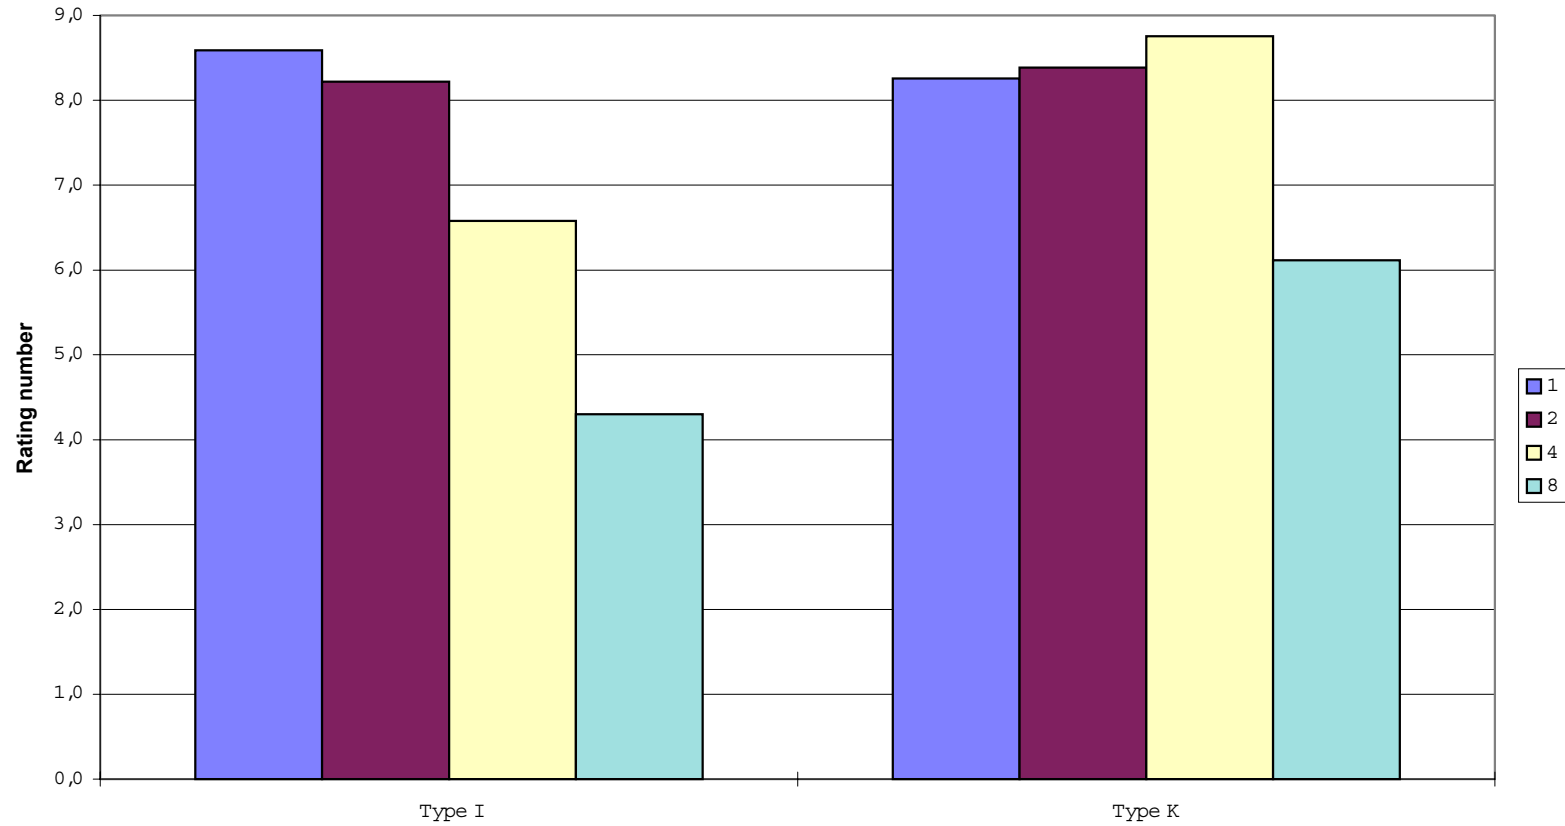
The results of types I and K are shown in the Tables 2.5 and 2.7 (Annex 2). The mean RN of all the sites is shown in Figure 1.10 (Annex 1). We see that the RN for type I has decreased from year to year. The general appearance of the type K was very good even after four years. But also this type has been considerably affected at the last evaluation.

Figure 1.10: General appearance after 1, 2, 4 and 8 years of exposure (medium values, all sites included).
