UN/ECE INTERNATIONAL CO-OPERATIVE PROGRAMME
ON EFFECTS ON MATERIALS, INCLUDING HISTORIC
AND CULTURAL MONUMENTS

Results from the multipollutant programme: Corrosion attack on painted steel after 1, 2 and 4 years of exposure (1997-2001)

NILU: OR 34/2003
REFERENCE: O-8208
DATE: JUNE 2003
ISBN: 82-425-1460-7

Odd Anda and Jan F. Henriksen

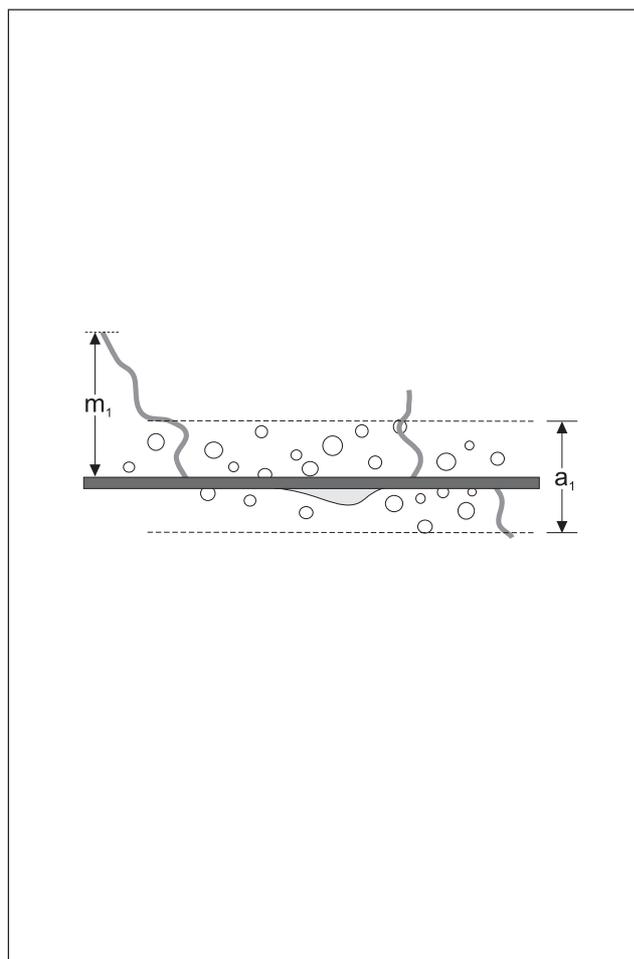
The evaluation has been focused on the spread of damage around an artificial cut through the paint measured in mm and given as the ASTM rating numbers from RN = 10 to RN = 0 (ASTM 1987). Beside the ordinary spread from the cut, filiform corrosion is observed around the cut on several of the test panels. Evaluation techniques for filiform corrosion are described in ISO standard 4623 (ISO 2000). The evaluation techniques have been different for the two corrosion types and this is illustrated in Figure 1.

The results of evaluation are presented in different way for the two types of attack. For spread from cut the total spread (a_1) excluding the filiform part is measured. The results are given as the mean spread of the three samples (a_m) in one direction after subtracting the width of the cut (1 mm)

Figure 1: Illustration of evaluation for spread from the cut and filiform corrosion on the test panels.
