# Modern Vehicle Hazards in Parking Structures and Vehicle Carriers

Haavard R. Boehmer\*, Michael S. Klassen and Stephen M. Olenick  
Combustion Science & Engineering, Inc.  
Columbia, MD, USA

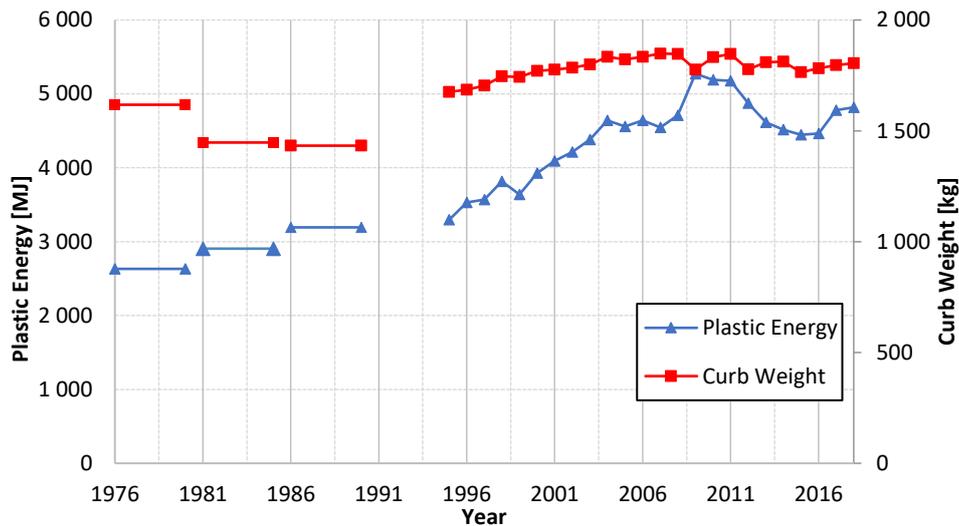
Figure 1 – Curb weight and plastic content potential fire energy from average North American vehicles from 1975 to 2018.

Heats of combustion were found from the literature for all but four of the remaining plastics, which represent a total of 10.1% by weight. The weighted and absolute average heat of combustion for the remaining 90% were both around 30 kJ/g (30.3 and 29.5 kJ/g respectively). Evaluating the changes in plastic content over time shows that for the three 5-year periods from 1976 to 1990 the total heat content (i.e. fire energy) from plastic content increased by an annual average between 47 – 52 MJ per year. Noting that there is a data-gap from 1991-95, the increase in plastic energy content from 1995 onwards was an average of 65.5 MJ/year. The total increase in energy content from plastics in the average vehicle (in the USA/NAFTA) from 1976 to 2018 was 2,298 MJ, a total increase of 91%. The increase in vehicle curb weight and plastic fire energy is plotted in Figure 1.

A full-scale fire test series performed on vehicles from the 1970s [20] gave an average value of 3,300 MJ over three vehicle tests. Using this value, the 2,298 MJ increase in potential fire energy from the plastic content up to 2018 represents a 70% increase in total fire energy from a full vehicle fire from 1970s. This is clearly a major increase in potential fire energy. Other factors may be important to the fire dynamics as well, such as the ease of ignition of plastics, and more rapid fire growth rate of vehicle fires involving significant plastic content.

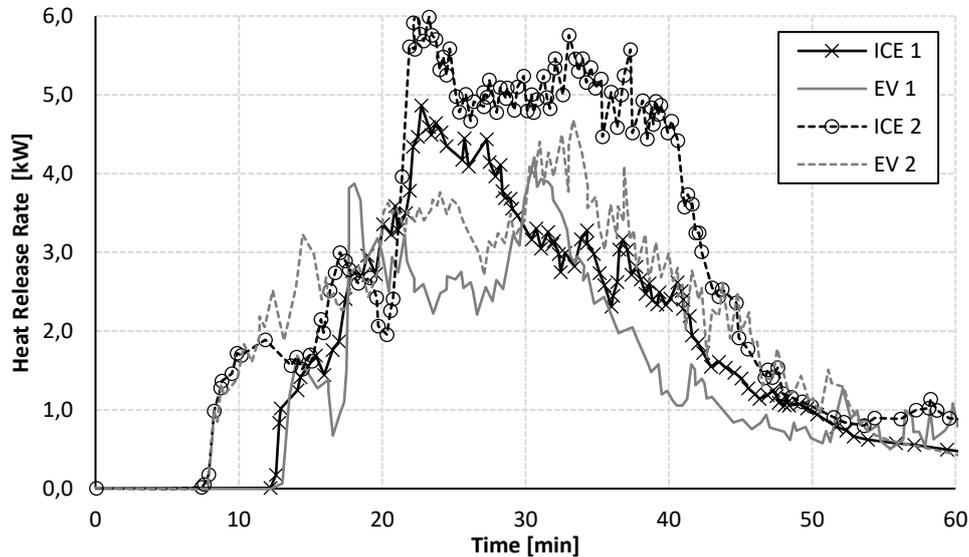
Figure 2 – Heat release rate for two pairs of similar ICE and EV vehicles for tests conducted by Lecocq [41]

gas burner placed in the front seat, with the window open. The peak heat release rate results were similar for the first pair at 4.2 MW and 4.8 MW, with the ICE vehicle being higher. For the second, larger pair, the EV had a peak of 4.7 MW, while the ICE vehicle had a peak HRR of 6.1 MW. The HRR plots for all four tests are shown in Figure 2. The ICE vehicles are represented by solid lines, while dotted lines are used for the EVs.

The figure shows that the heat release rate for the first vehicle pair is very similar, both in peak HRR, and in growth rate. The second pair start with similar growth for the first 20 minutes, when the HRR for ICE 2 rapidly increased to its peak value and stays higher than the EV 2 curve until near the end.
