Comparison of two test methodologies for fire testing of façade systems

RISE RAPPORT 130011-08B
Mikael Bergius

RISE rapport 2023:29 ISBN 978-91-89757-75-2 Project number: 130011-05B

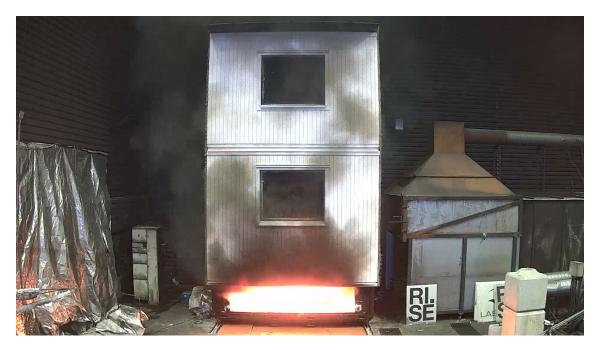
Photo 1 SP Fire 105, 0 minutes after first flames emerge out of the fire room.
